# SAFETY INSPECTION REPORT

**Site name:** North Tawton Memorial Park

**Site owner/operator:** North Tawton Town Council

**Date of inspection:** 7 August 2026

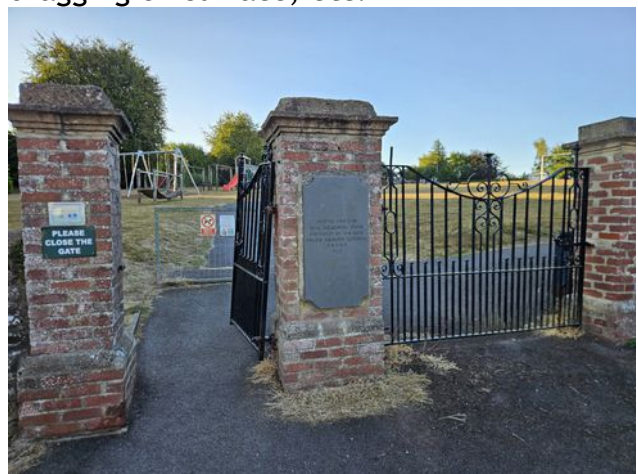
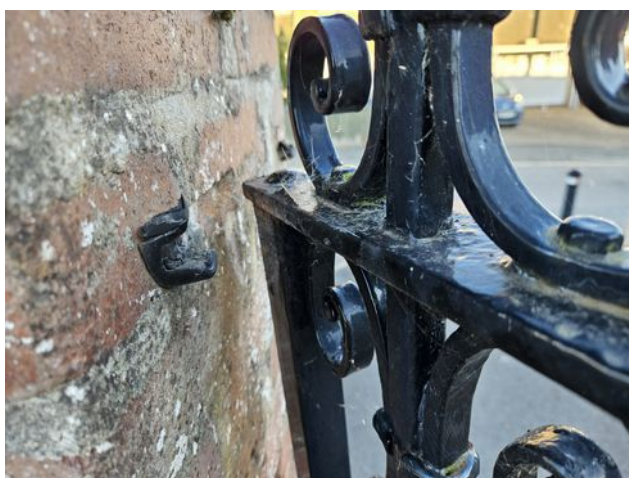
Perimeter gates are of varying designs, none of which are specifically intended for children's play areas. In particular the heavy iron gates have potential for misuse. Other gates have some wear in hinges, dragging on surface, etc.

Risk: 8 (medium)

**Suggested remedial action:** Keep the large maintenance/vehicle gate locked to prevent misuse. Replace worn/damaged rubber buffers on the pedestrian side. Monitor use and consider modifications if deemed necessary. If gates require replacement in future, consider providing safer gates that are designed for play spaces.

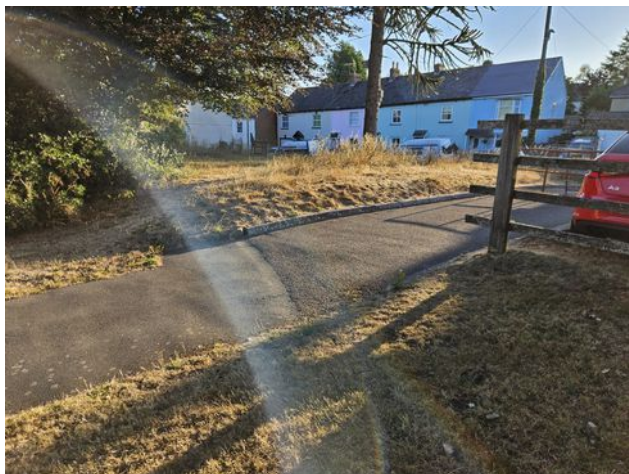
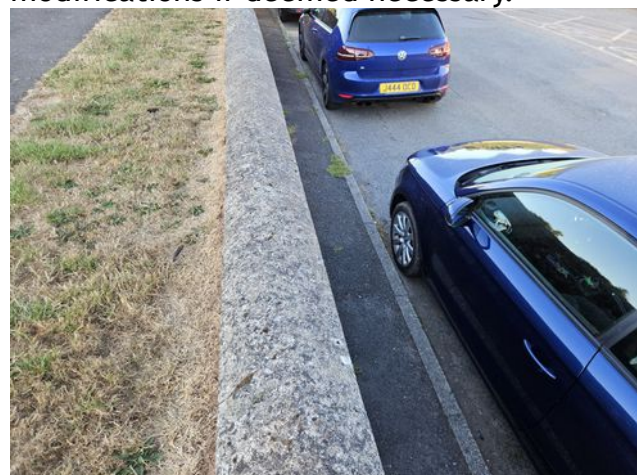
**Findings: 1.** From certain angles it could appear as though the site is fully enclosed, and the various gates give that impression as well, however there are several ways children (and/or dogs, if off lead) could easily exit the site. This includes the exit to the car park (which does not have a gate), as well as the low level stone wall which, in places, leads to a considerable potential fall onto pavement below. There is also damage to residential fencing that borders the site.

**Risk: 8 (medium)**

**Suggested remedial action:** Ensure residential fencing is repaired and there are no gaps/holes which lead from play area in to private properties. Monitor use and consider further modifications if deemed necessary.

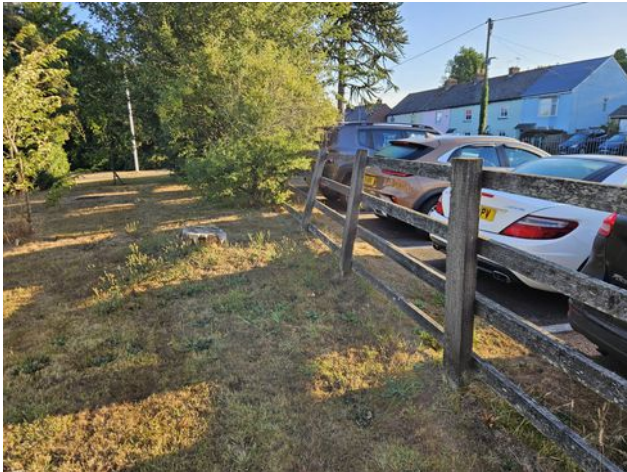
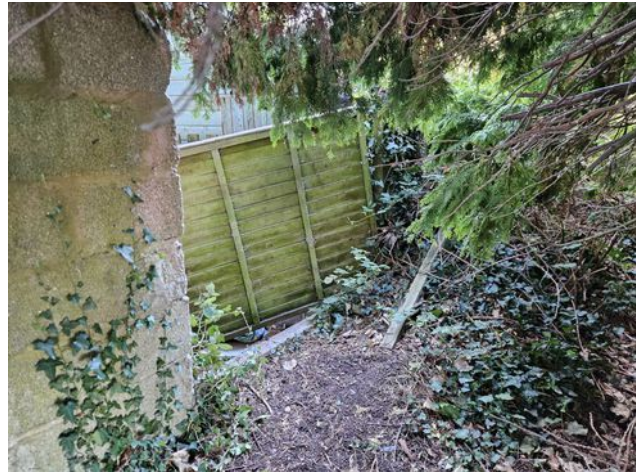
2. Timber post & rail fencing near carpark is in poor condition, with severe rot in several of the posts (to the point where they've snapped off at the base).

**Risk:** 12 (medium)

**Suggested remedial action:** Repair or replace rotten/damaged fencing.

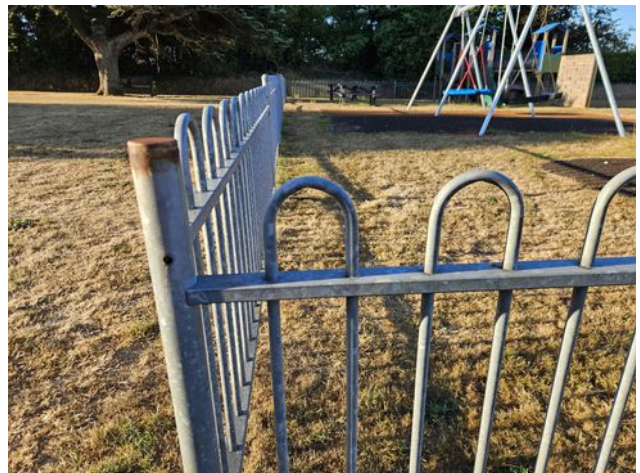
1. This older style of bowtop fencing with the faller top hoops contains potential for head/neck entrapment. While fencing isn't playground equipment and isn't required to meet the same standards, it is still recommended.

**Risk:** 6 (low)

**Suggested remedial action:** Monitor use and consider modifications if deemed necessary. Ensure any new fencing provided in future meets with the requirements of the standards.

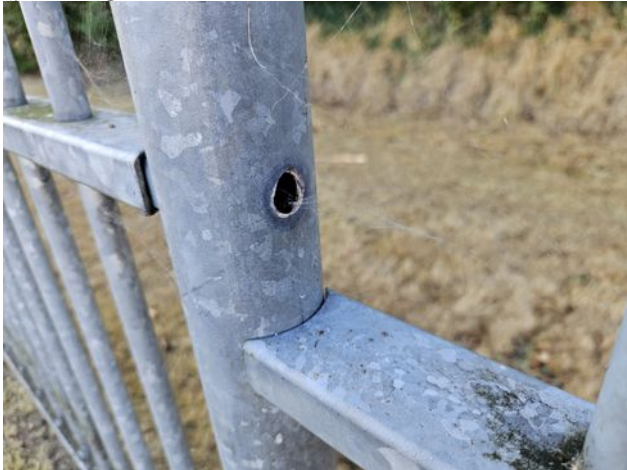
2. Missing caps/plugs expose sharp-edges holes which could trap fingers.

**Risk:** 6 (low)

**Suggested remedial action:** Replace missing caps/plugs.

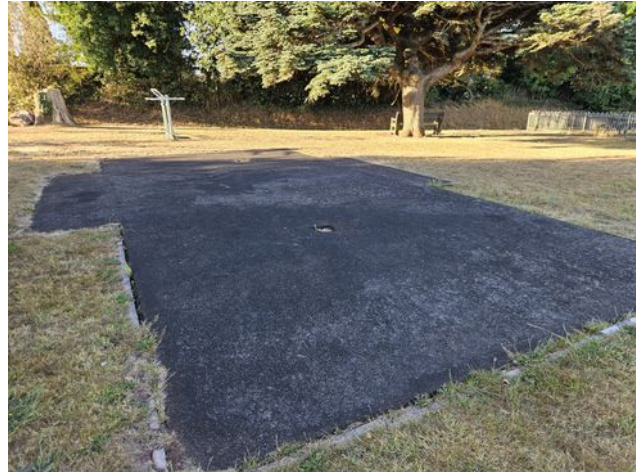
There is an unused/redundant patch of old wetpour rubber surfacing, which has various trip hazards, etc. The surface is actually in reasonable condition and could be repaired/reused with new equipment in future.

**Risk: 8 (medium)**

**Suggested remedial action: Monitor use**

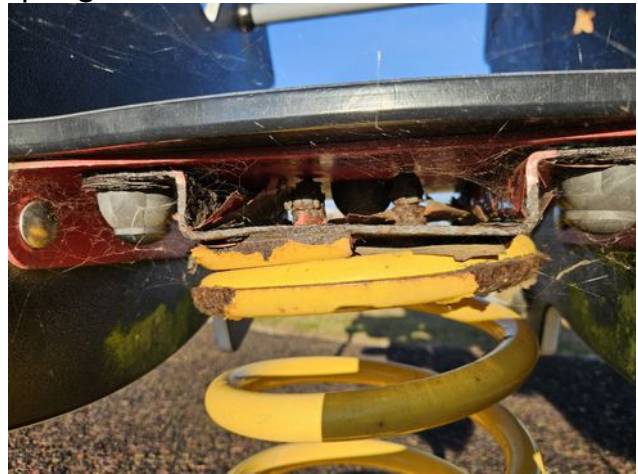
There is significant rust/corrosion around where the rocker body attaches to the spring.

**Risk:** 8 (medium)

**Suggested remedial action:** Monitor for further deterioration and repair or replace as needed.

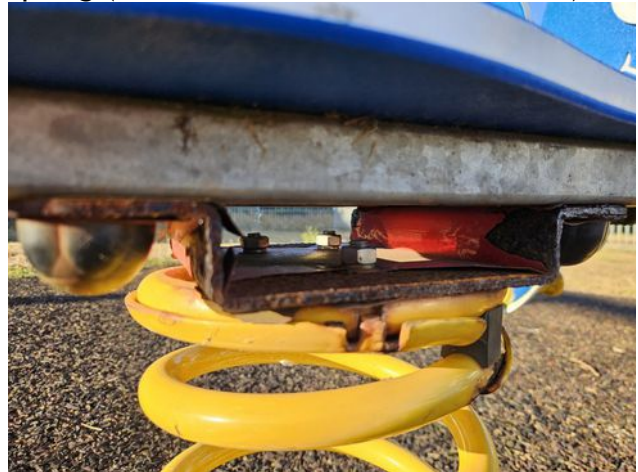
There is significant rust/corrosion around where the rocker body attaches to the spring (less severe than the rocker cow).

**Risk:** 6 (low)

**Suggested remedial action:** Monitor for further deterioration and repair or replace as needed.

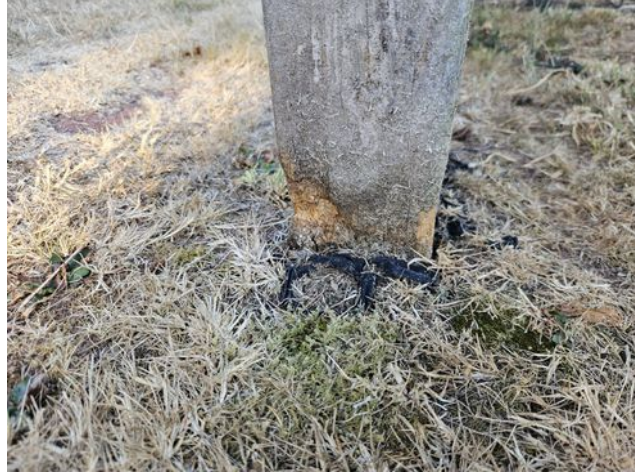
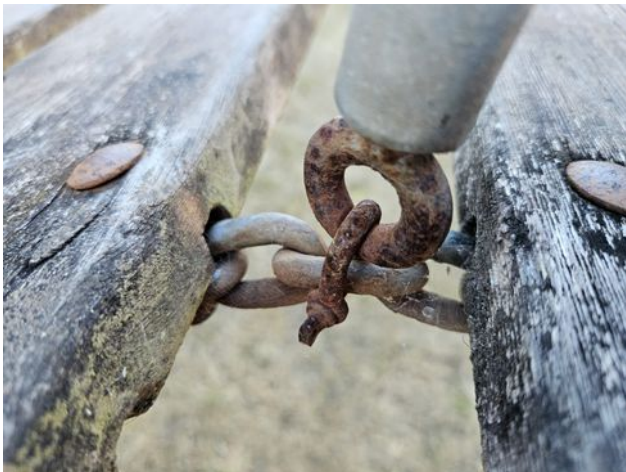
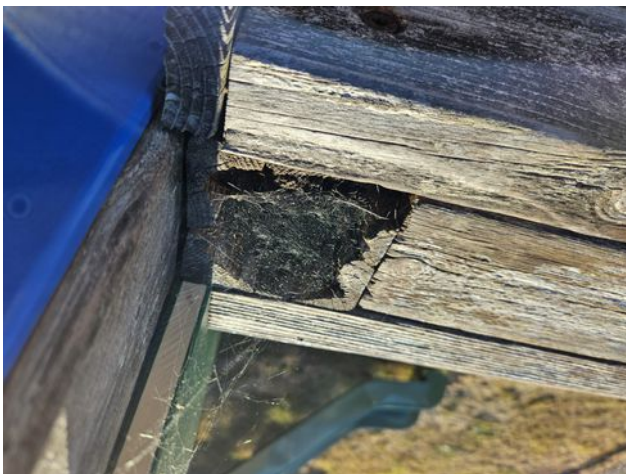
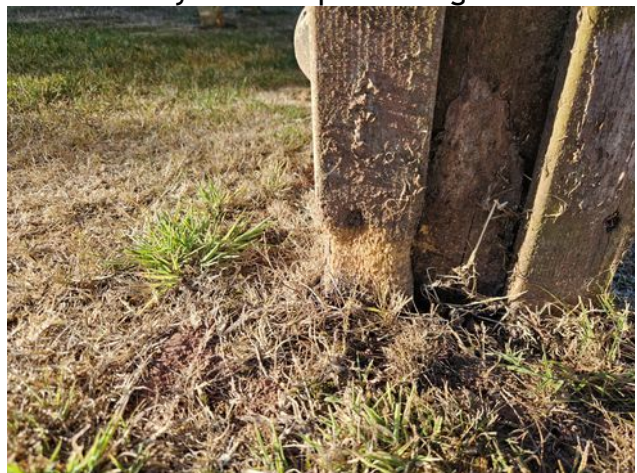
**Findings:** The unit is showing its age, and there is evidence of timber rot, rusty /notched fixings throughout. That being said, none of this seems to be causing any urgent issues, and the unit feels generally pretty solid.

**Risk:** 12 (medium)

**Suggested remedial action:** No immediate action is required, but timber rot is unpredictable, and the unit should be checked for further deterioration and structural stability on a routine basis. Replacing all of the affected timbers would likely not be practicable, so the recommended course of action is to monitor and repair where possible/practicable, and plan for future replacement of the whole unit. Pay particular attention to the climbing net and climbing wall, as these sections rely on a single post for their stability, and could fail suddenly if outer post lets go.

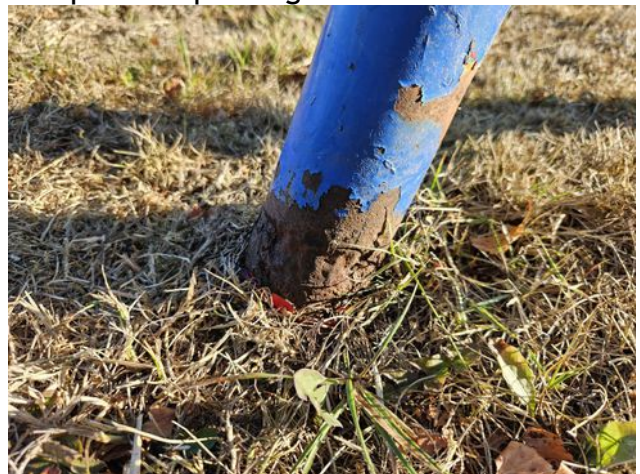
Swing frame in generally poor condition and nearing end of useful service life (without considerable repairs).

**Risk:** 12 (medium)

1. There is considerable rot/corrosion in swing frame at/below ground level. It is not possible to assess the full extent without excavating around the base of the legs, but frame is currently stable. Treat and paint to prolong service life.

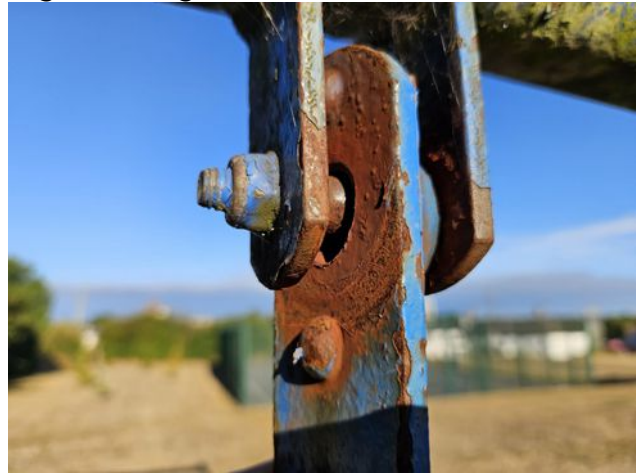
2. Swing hanger bushes long gone, and there is internal wear/damage to swing hangers, though, again, not causing any urgent or high risk issues.

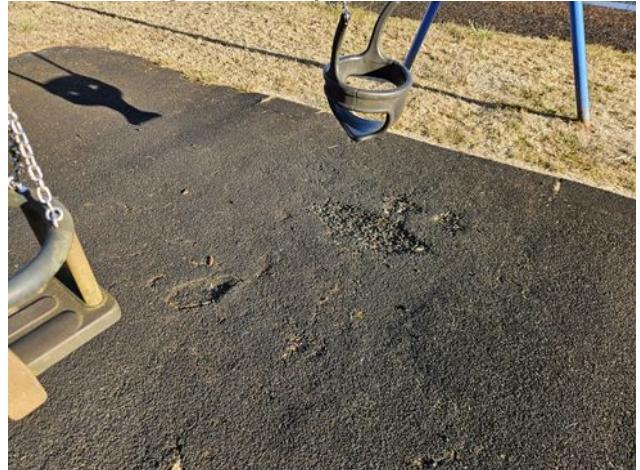
3. Surfacing needs repair.

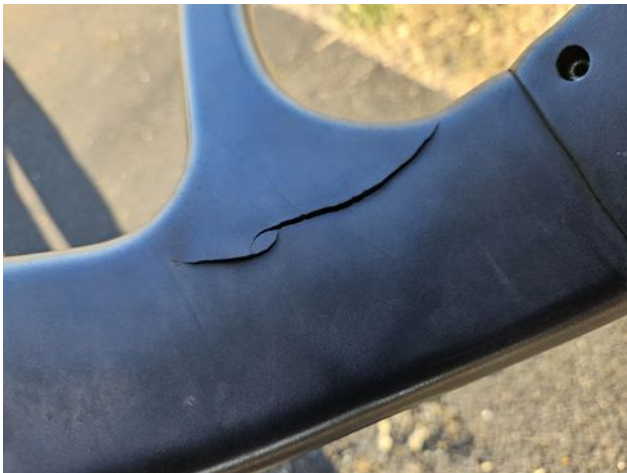
4. Some seat wear/damage. Monitor for further deterioration.

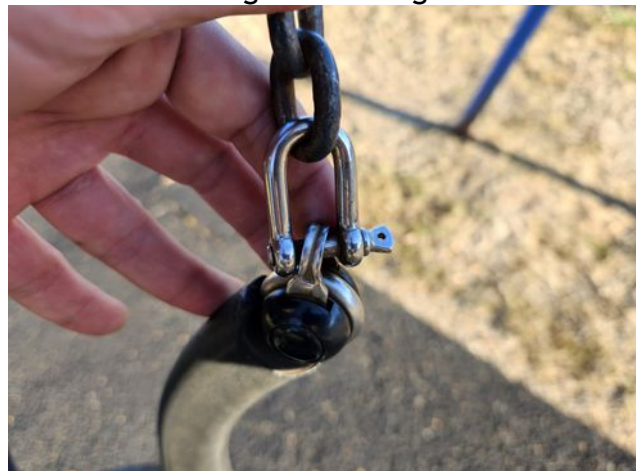
5. Tab-end shackles are not recommended as these can snag on clothing.

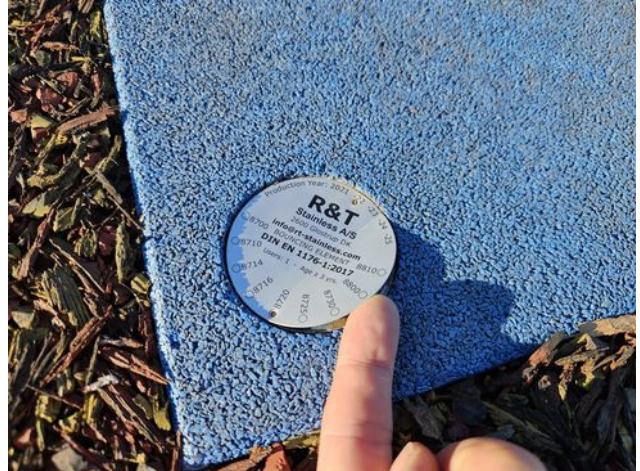
ID tag loose/damaged, exposing sharp edge

**Risk:** 5 (low)

**Suggested remedial action:** Remove damaged ID tag.

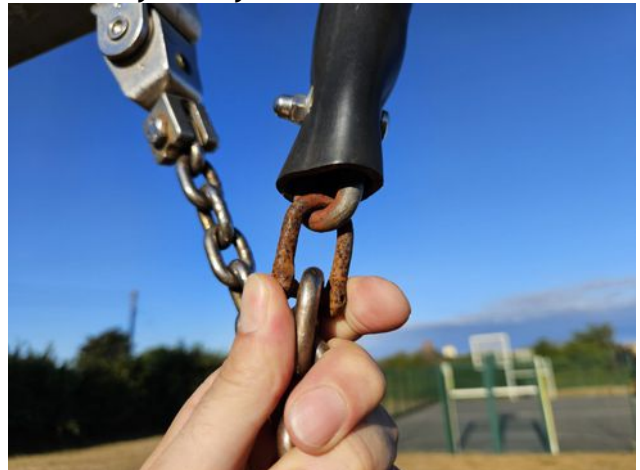
1. Some corrosion / chain wear in the secondary safety chains.

**Risk:** 6 (low)

**Suggested remedial action:** Replace rusty parts.

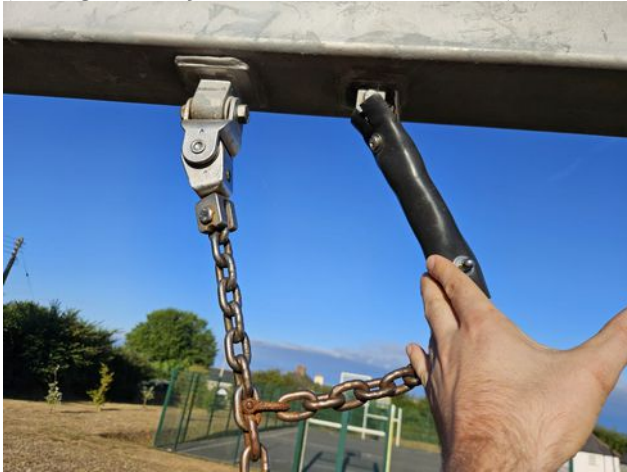
2. The opening created by the secondary safety chains fails the requirements for protection against entrapment.

**Risk: 8 (medium)**

**Suggested remedial action:** Eliminate entrapment potential by shortening secondary safety chains slightly. This can be done at the same time as replacing the rusty connecting links.

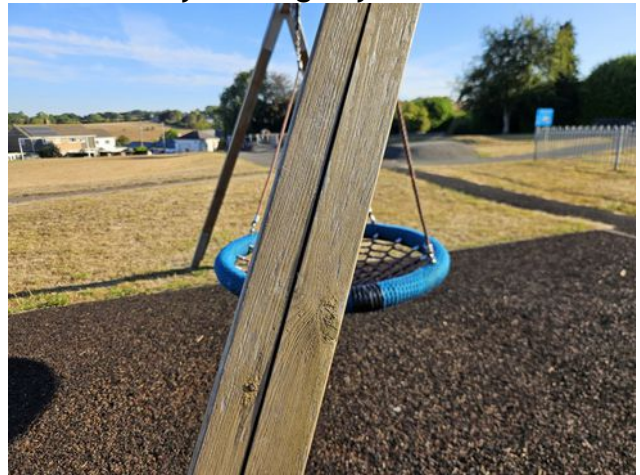
3. There is a split in the swing frame leg, not currently causing any issues.

**Risk: 8 (medium)**

**Suggested remedial action:** Monitor for further deterioration and/or any structural instability.

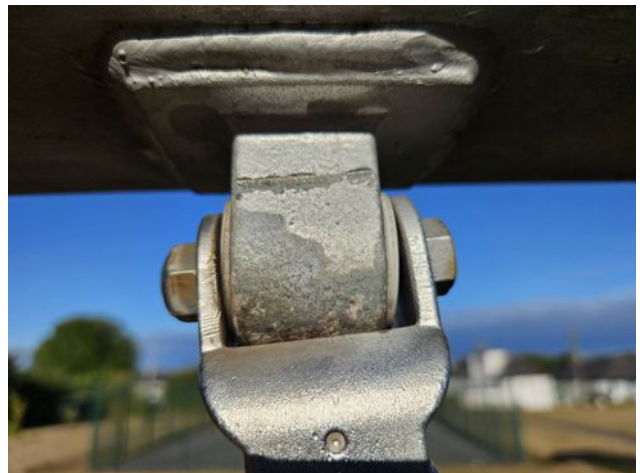
4. There is wear in the swing hanger bushes.

**Risk: 6 (low)**

**Suggested remedial action:** replace worn bushes.

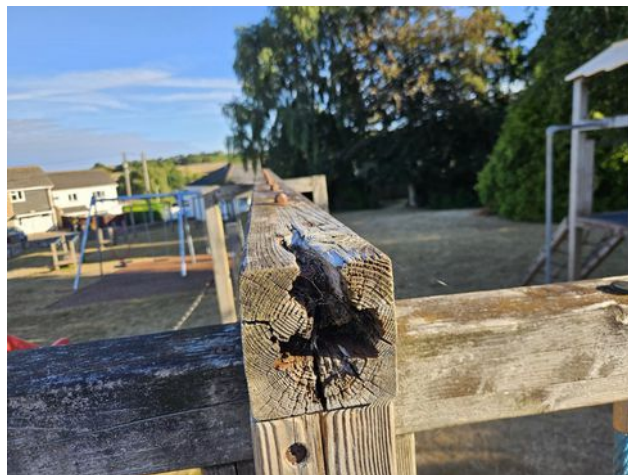
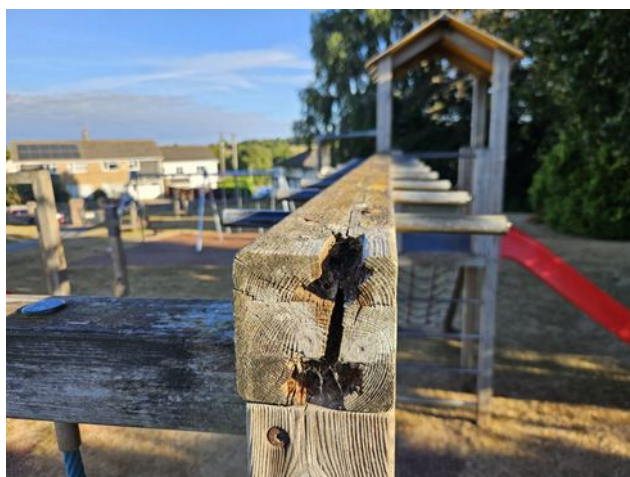
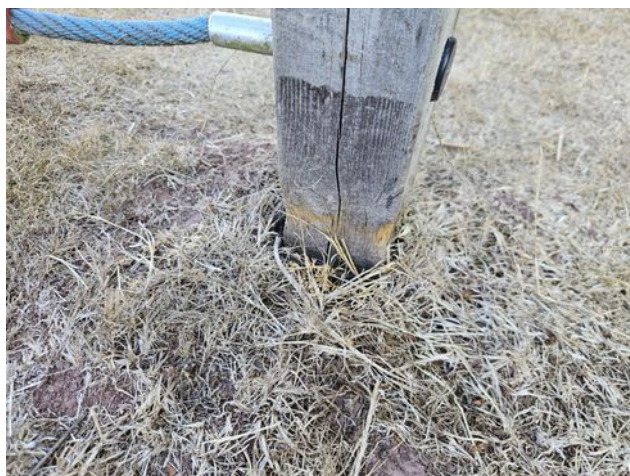
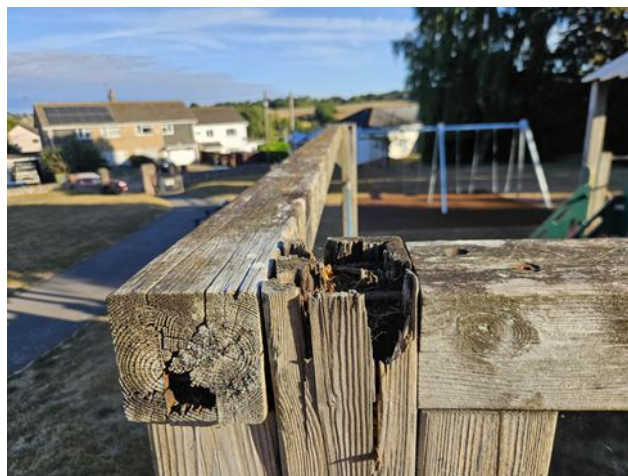
The unit is showing its age, and there is evidence of timber rot, rusty /notched fixings throughout. That being said, none of this seems to be causing any urgent issues, and the unit feels generally pretty solid.

**Risk:** 12 (medium)

**Suggested remedial action:** No immediate action is required, but timber rot is unpredictable, and the unit should be checked for further deterioration and structural stability on a routine basis. Replacing all of the affected timbers would likely not be practicable, so the recommended course of action is to monitor and repair where possible/practicable, and plan for future replacement of the whole unit.

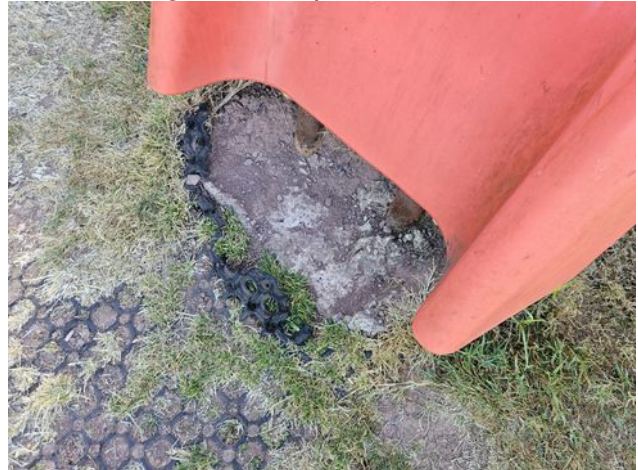
2. Surfacing needs repair.

**Risk:** 8 (medium)

**Suggested remedial action:** Repair or replace damaged sections.

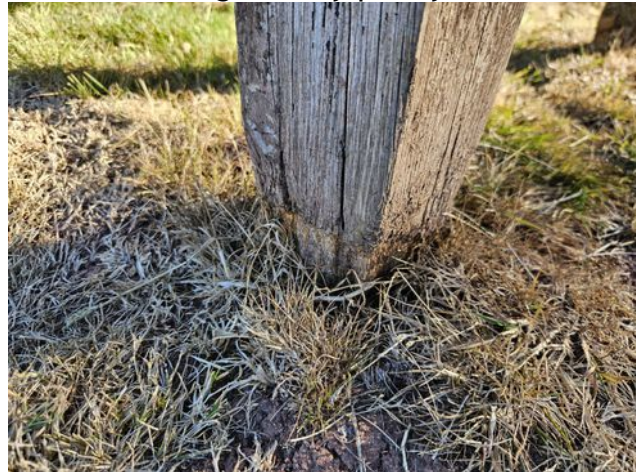
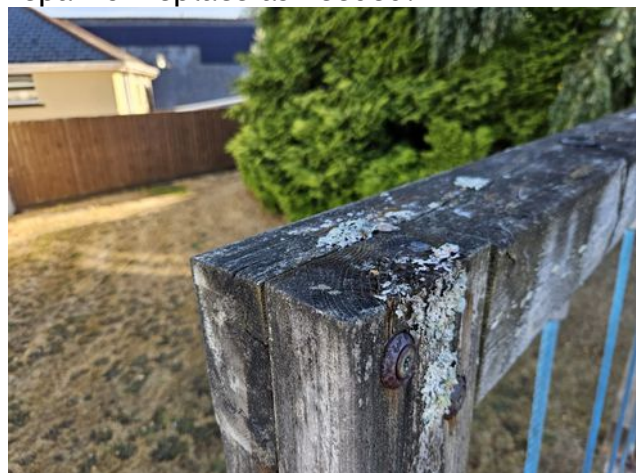
The agility trail is showing its age, and there is evidence of timber rot throughout. That being said, none of this seems to be causing any urgent issues, and the various elements feel generally pretty solid.

**Risk:** 12 (medium)

**Suggested remedial action:** No immediate action is required, but timber rot is unpredictable, and the unit should be checked for further deterioration and structural stability on a routine basis, paying particular attention to the parts that rely on a single post for stability, with heavy overhead beams that could come down.

Monitor for further deterioration and repair or replace as needed.

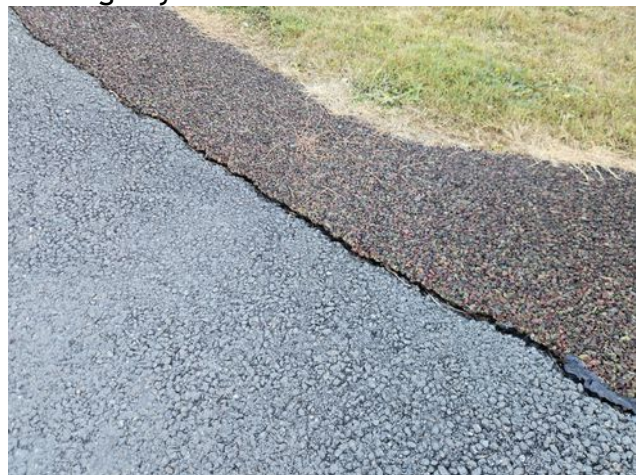
**Findings:**  
Minor separation between tarmac and bonded rubber mulch edging. Not currently causing any issues.

**Risk:** 6 (low)  
**Suggested remedial action:** Monitor for further deterioration and repair as needed.

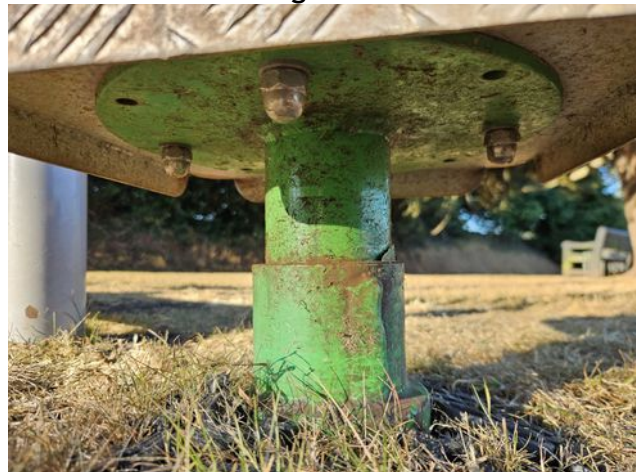
**Findings:**  
Hip twister bearing worn, and limiter function not working.

**Risk:** 8 (medium)  
**Suggested remedial action:** Replace worn bearing.
