# Safety Inspection Report

Annual Inspection

North Tawton Town Council

06 March 2026

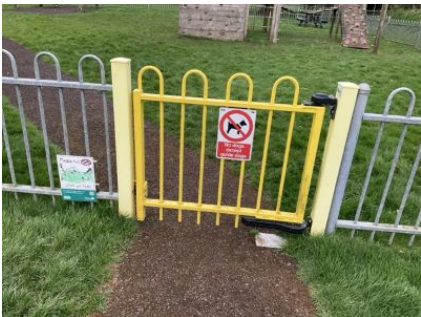
Dog ban & ownership signs recommended.

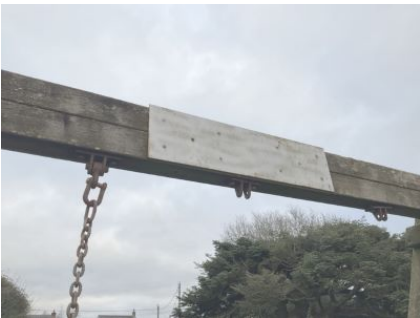
Monitor small crack in top bar. Crack has been boarded over. Consider replacement swing.

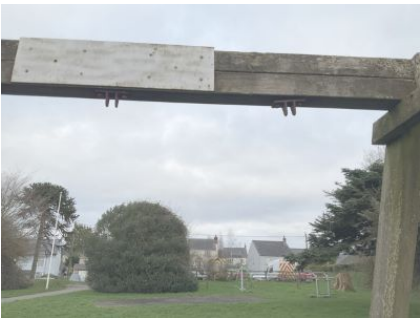
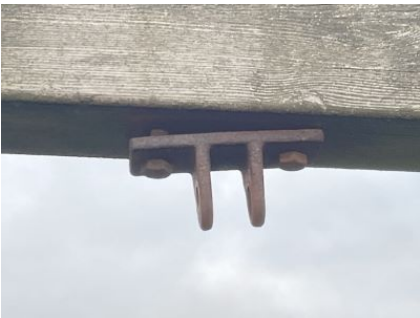
Swing seat(s) missing.

Seat removed, swing hanger loose.

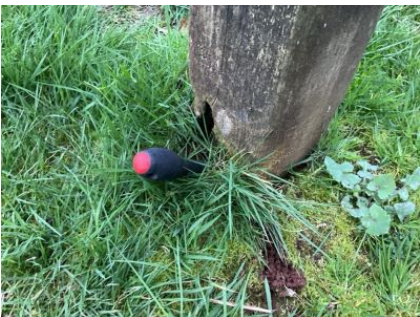
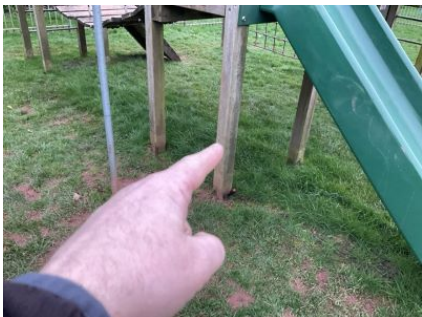
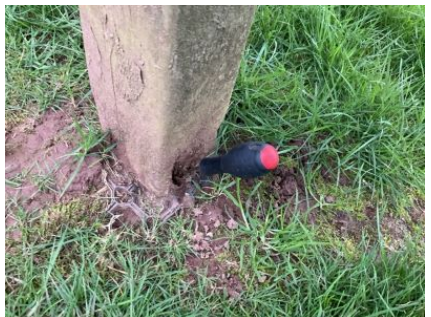
Timber is decayed.

Several posts decaying at ground level (see photos).

Replace affected parts.

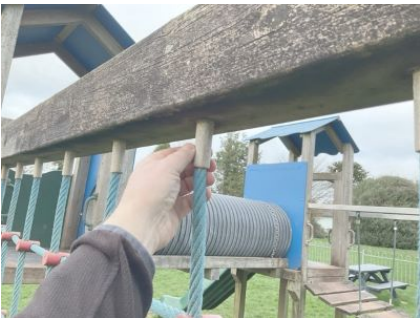
Periodically disconnect the rope net connectors to check for corrosion to the bolt fittings and replace if found as corrosion and collapse has been know to occur similar connectors.

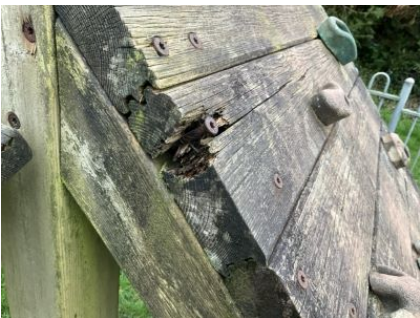
Timber is decayed.

Ramp slat decayed and splintering.

Replace affected parts.

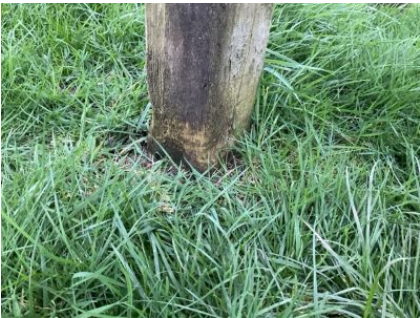
Strimmer damage is present on posts, allowing water to enter and timbers to soften. It can also remove the protective envelope around the timber. Prevent further damage and check timbers for decay throughout the year.

Prevent further damage.

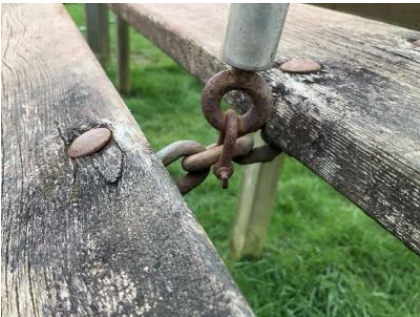
Fittings are rusty.

Replace.

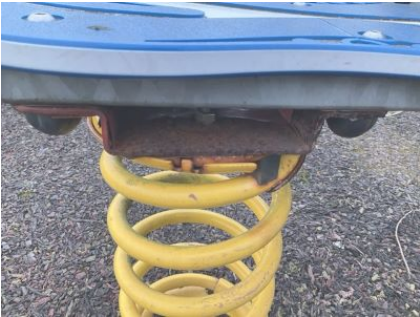
Paintwork is in poor condition.

Spring tops rusting.

De-scale back to good base material and coat with lead free paint, using appropriate precautions. Repairs may be necessary where corrosion is severe.

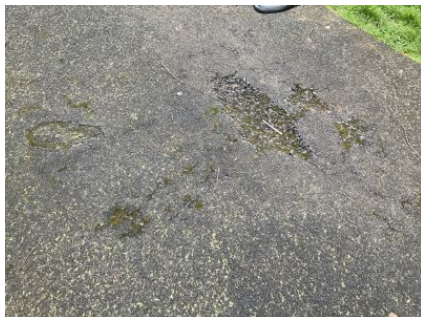
Surface is wearing.

Surface wearing under seat and sinking in places. Repair.

## Repair.

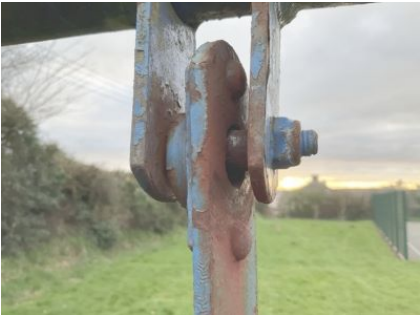
Item is worn.

Swing housing bolts wearing. Replace hangers x 2.

Replace.

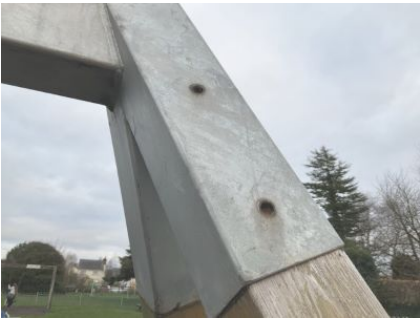
Screws or bolts are missing.

Top bar screws to support leg have pushed through the fixing hole. Replace.

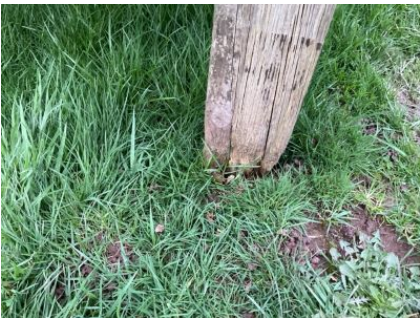
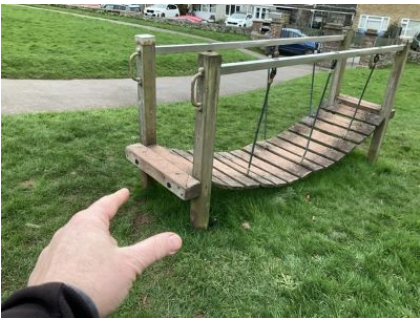
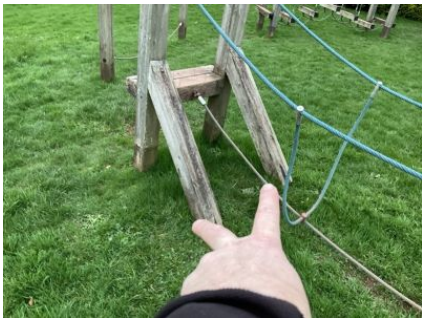
Timber is decayed.

Posts decaying at ground level on the suspension bridge and Burma bridge. Other timbers are softening at ground level. Replace posts or consider replacing the units.

Replace affected parts.

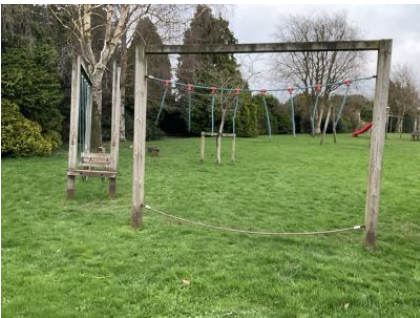
This equipment relies on one post for its stability. Special attention should be paid to maintenance (e.g. by monitoring degradation) and if necessary decommissioning the item before the end of its operating life. This is a requirement of the British Standard.

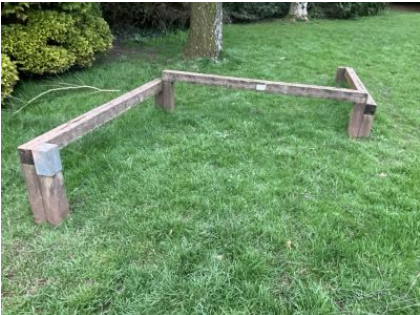
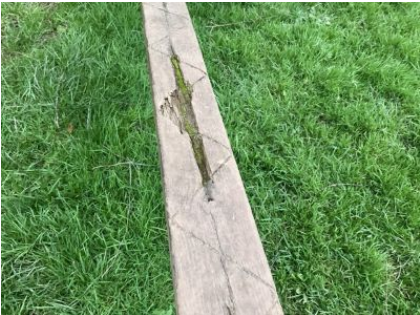
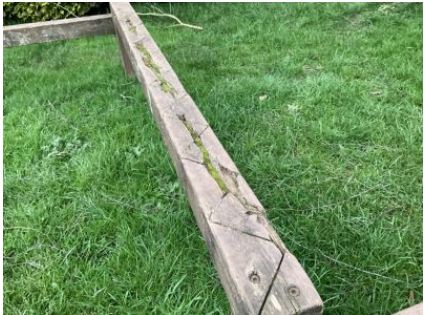
Balance beams splintering and showing signs of decay. Replace.

Replace.

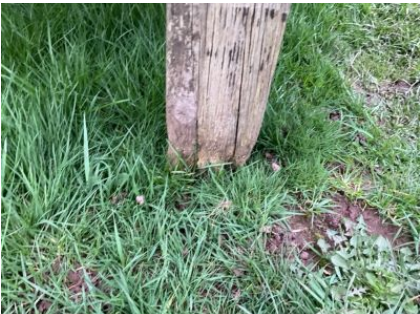
Strimmer damage is present on posts, allowing water to enter and timbers to soften. It can also remove the protective envelope around the timber. Prevent further damage and check timbers for decay throughout the year.

Prevent further damage.

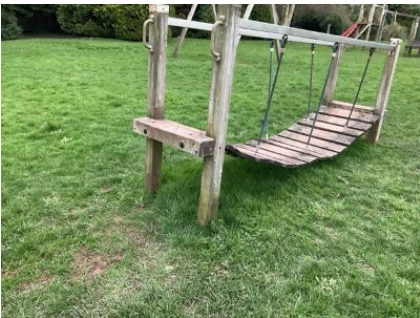
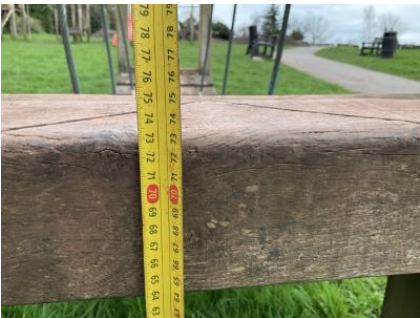
Item has some parts missing.

Section missing from the suspension bridge and Burma bridge. Leaving large drops from the access points.

Replace the missing parts.

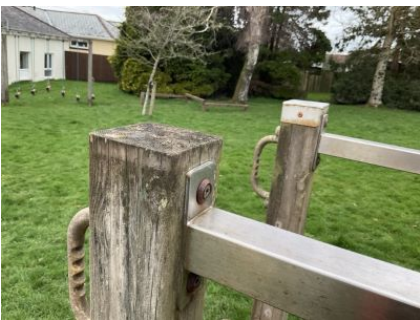
Cap missing.

Post caps missing leaving sharp edges.

Replace.

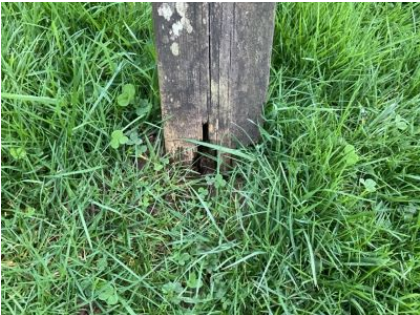
Two support legs closest to the pathway has decayed at ground level.

Programme early replacement.

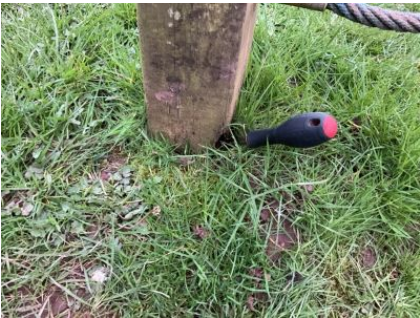
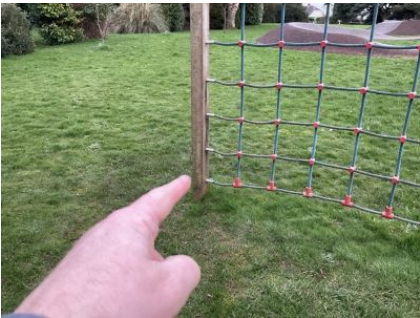
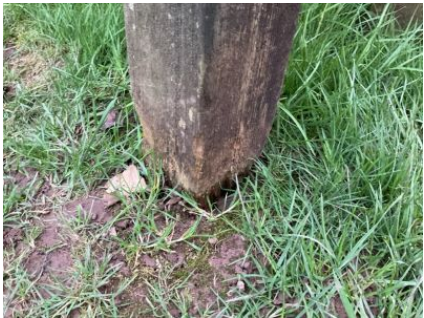
There is decay to timber components which may affect structural integrity. We do not recommend replacing rotten supports with timber posts which are directly set in the ground due to the increased problem of timber rot, especially in posts in contact with the ground.

Several posts decayed and others softening. See photos for identification. Replace. Top bar beam ends and braces decayed. Replace. Two posts have been capped, so our inspector cannot determine the condition of the posts. Check for determination. Replacements are required. However, consideration should be made to replacing this unit.

Replace decayed components where possible and plan replacement of item. Check on a routine basis, especially at ground or foundation level., Read the notes for further action.

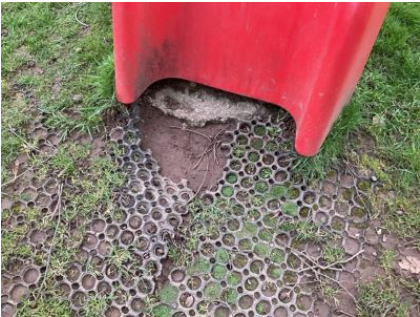
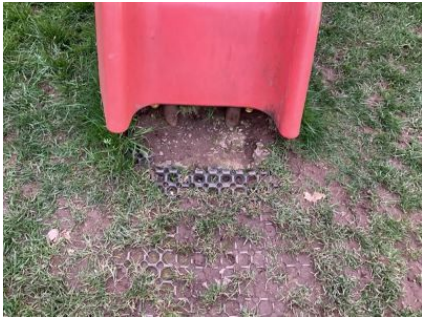
The foundations should be designed such that they do not present a hazard (tripping, impact). Care should be taken to ensure that foundations are not exposed as a result of erosion.

Foundations exposed at the bottom of the slide and the grass mat has been damaged. Replace damaged grass mat.

Eliminate the hazard.

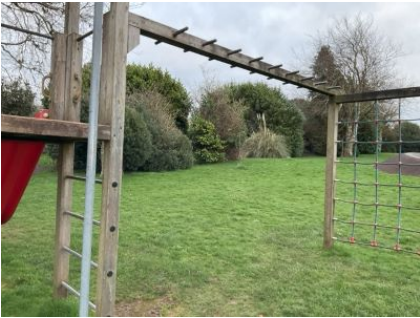
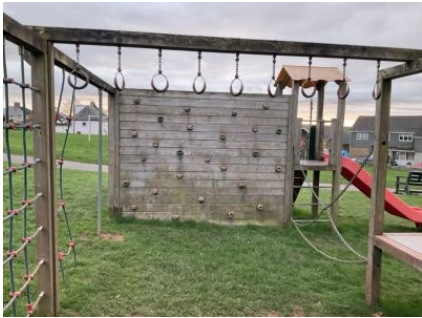
Overhead ladders and rings provide significant play value and benefits to children, and with it the risk of falling. Ensuring the surface remains in good condition will help to keep the correct balance between benefits and risk.

The protective surface under all bars and rings must be kept in good condition.

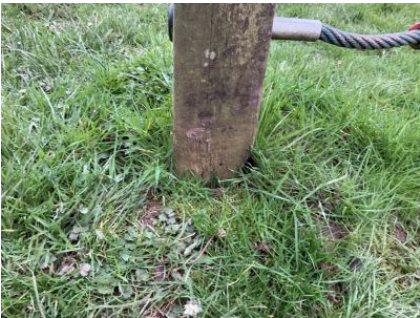
Strimmer damage is present on posts, allowing water to enter and timbers to soften. It can also remove the protective envelope around the timber. Prevent further damage and check timbers for decay throughout the year.

Prevent further damage.

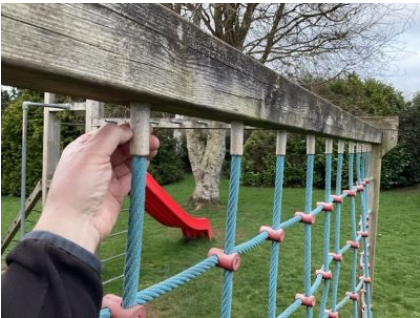
Periodically disconnect the rope net connectors to check for corrosion to the bolt fittings and replace if found as corrosion and collapse has been know to occur similar connectors.

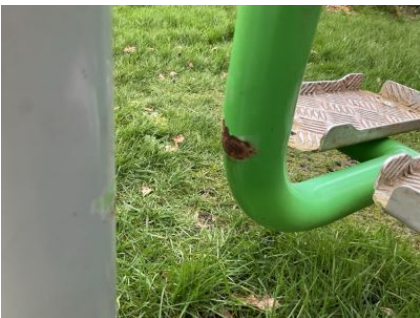
| Description | Tasks | Risk score |
|---|---|---|
| The paint is chipped. | Touch up the paint. | 3 |
