WEST DEVON BOROUGH COUNCIL

# **NORTH TAWTON CONSERVATION AREA**

## **CHARACTER APPRAISAL**

by  
**John Fisher MA MRTPI**

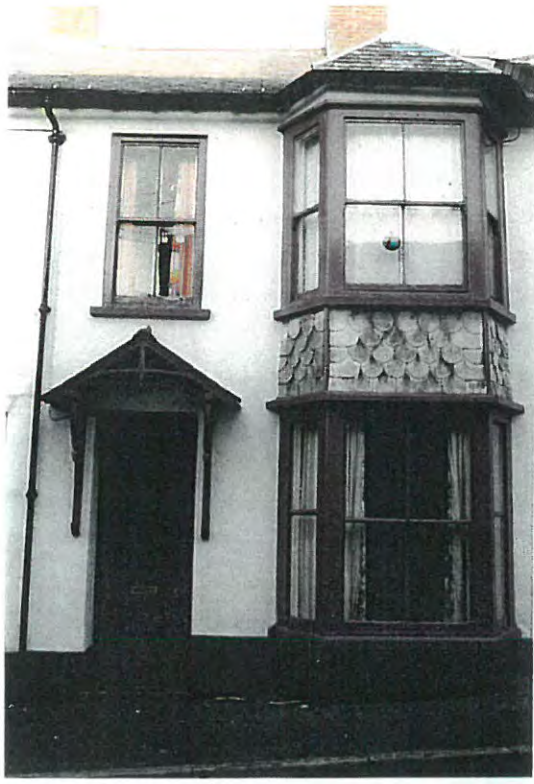
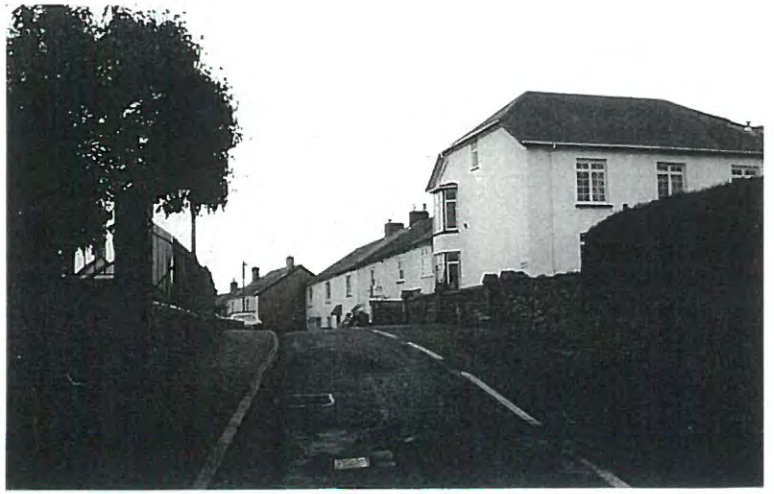
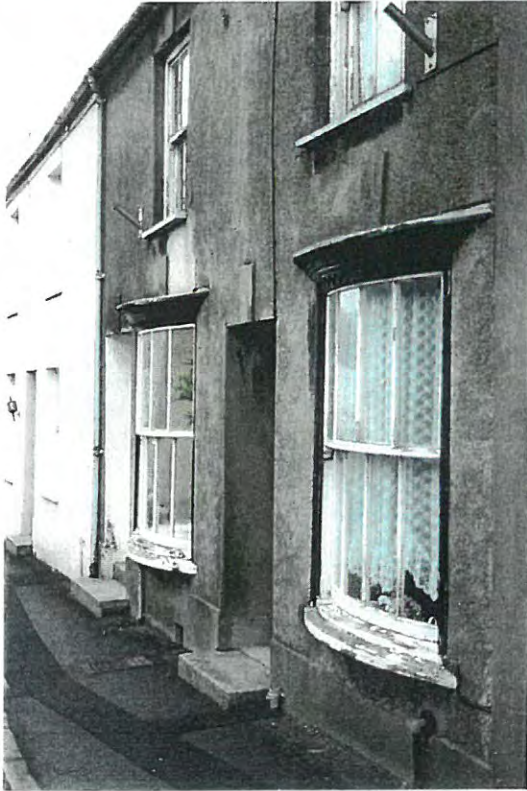
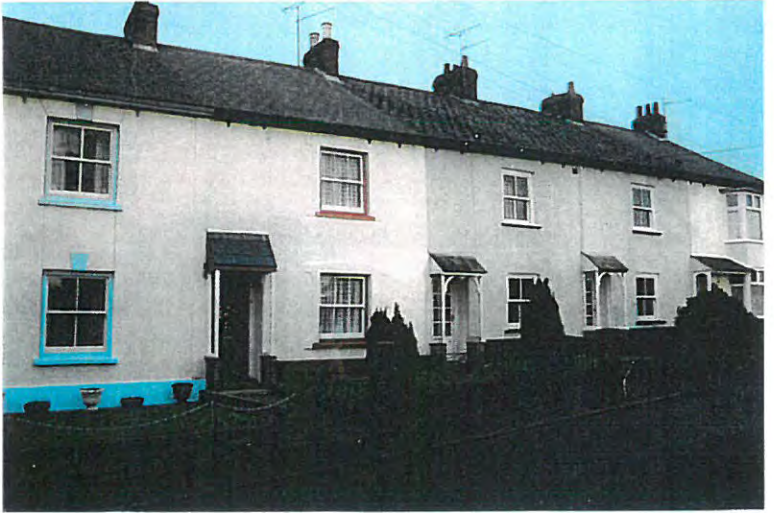
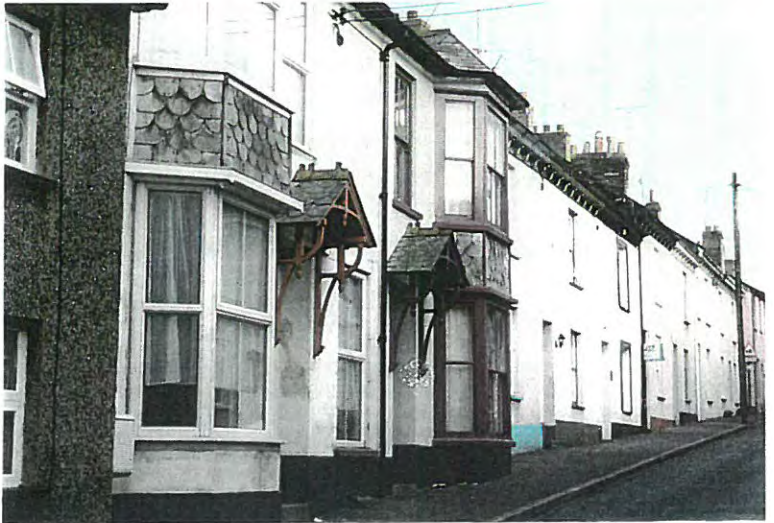
## HIGH STREET

*(Top & bottom left) Characteristic earlier (how double fronted) and later (2storey bay) 19th century frontages, completely unaltered. Again, unpainted render adds contrast.*

*(Top right) Entry to the town from the north is dramatic and sudden over the brow of a hill.*

*(Centre right) Two views of the pleasing and little altered frontages on the east side. Note porches, bracketed eaves and Cornish "fish-scale" slate hanging.*

*(Bottom right) View from corner of Barton Street towards The Square which will be enhanced by removal of power lines and would further benefit from discreet wall-mounted street lighting. Note glimpses of open countryside above rooftops.*

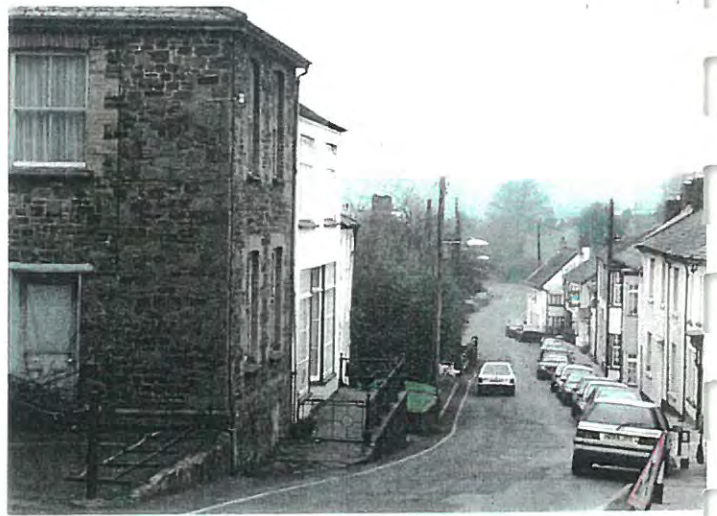
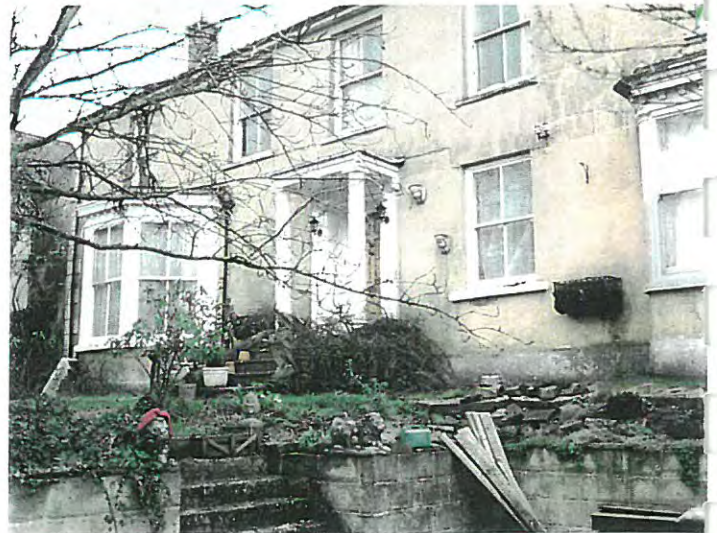
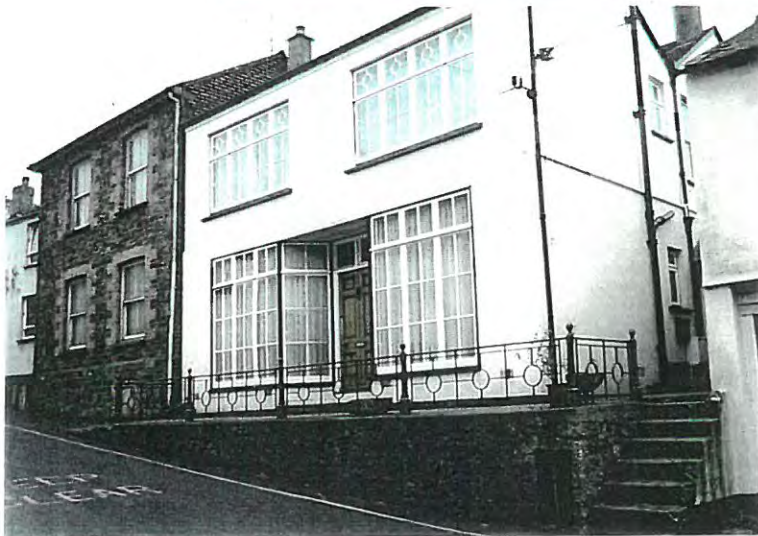
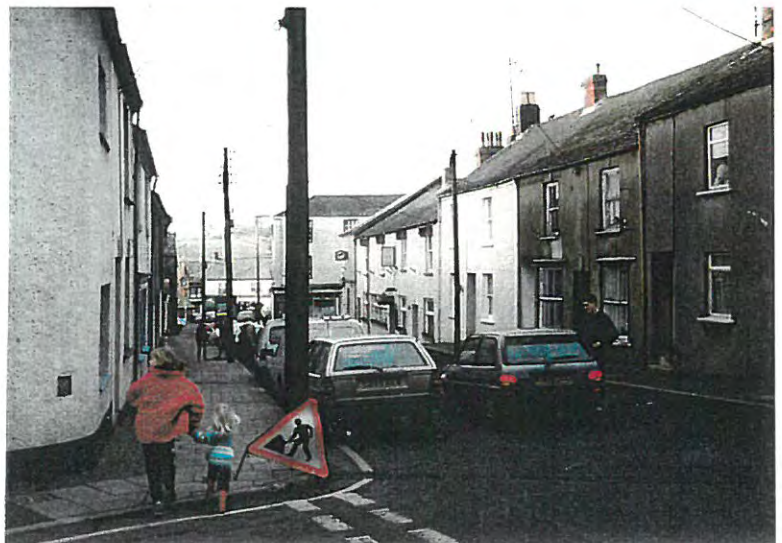
## FORE STREET

*(Top right) General view; this is one of the few points in the town where distant views beyond are obtainable. The slope allows some interesting changes in level between adjacent buildings and boundaries.*

*(Top left) A tri-partite sash window, probably 19th century needing some attention. Such windows do not necessarily have statutory protection, although in this case the building is listed. Replacement of authentic detail readily detracts from a historic building's character whether listed or not.*

*(Upper right and lower left) Nos 15-19; examples on the south side of unlisted buildings, retaining mostly authentic detail e.g. panelled doors and sash windows. Note how the pattern in metal railings is echoed in first floor window top vents. Steps add interest to changes of level.*

*(Lower right) Nos 38-40; adjacent early 19c listed buildings with original hooded and moulded doorcases and panelled doors.*

*(Bottom) Nos 66-68; a listed pair, not at present in the conservation area, date from the late 17th century.*

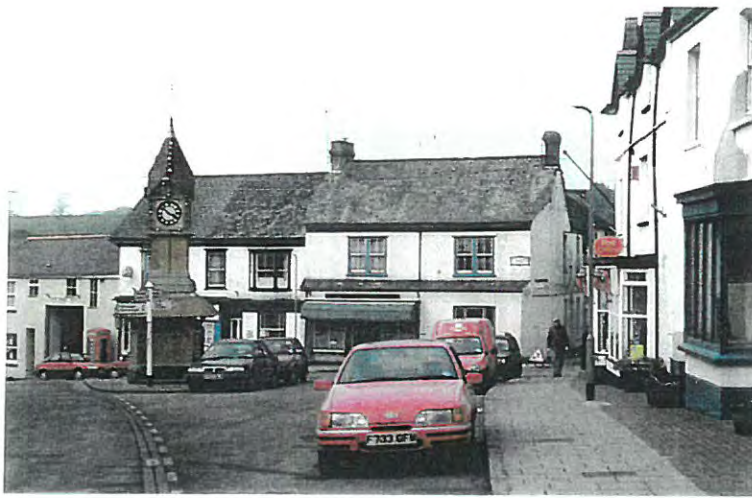
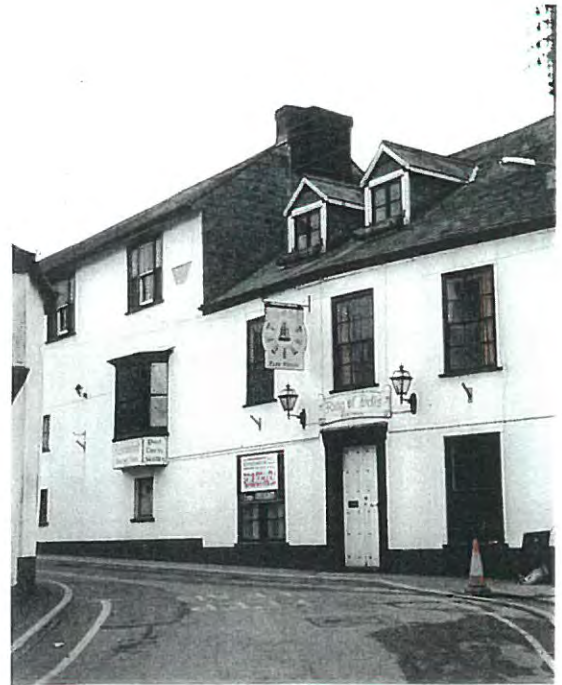
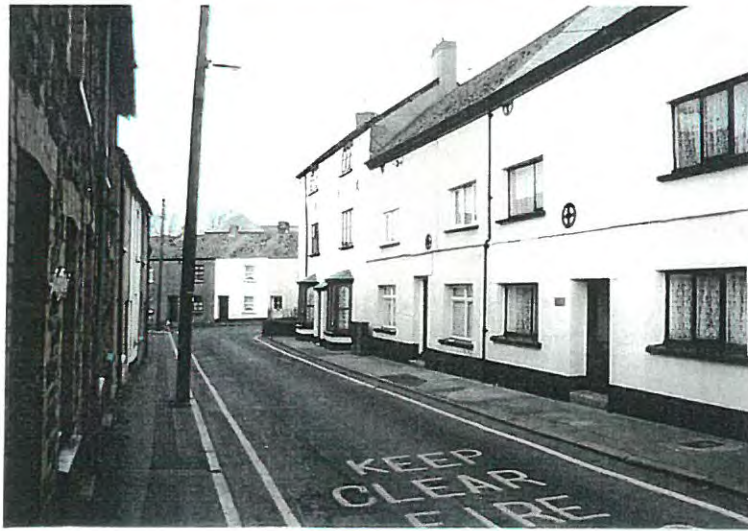
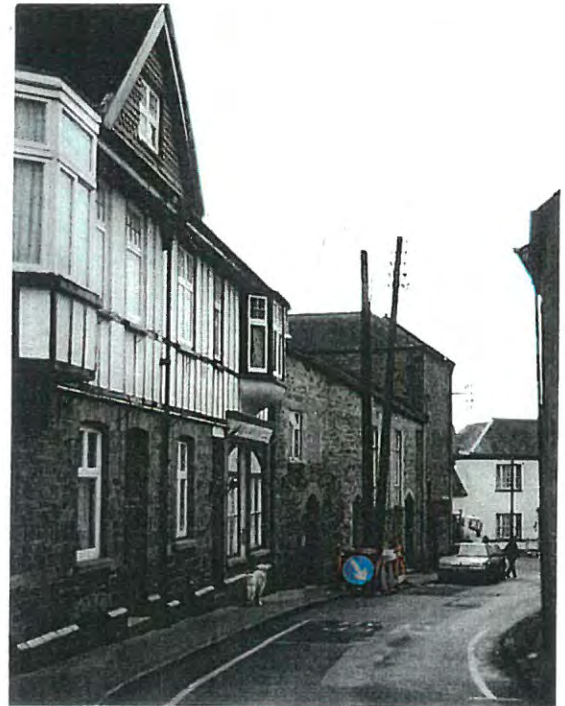
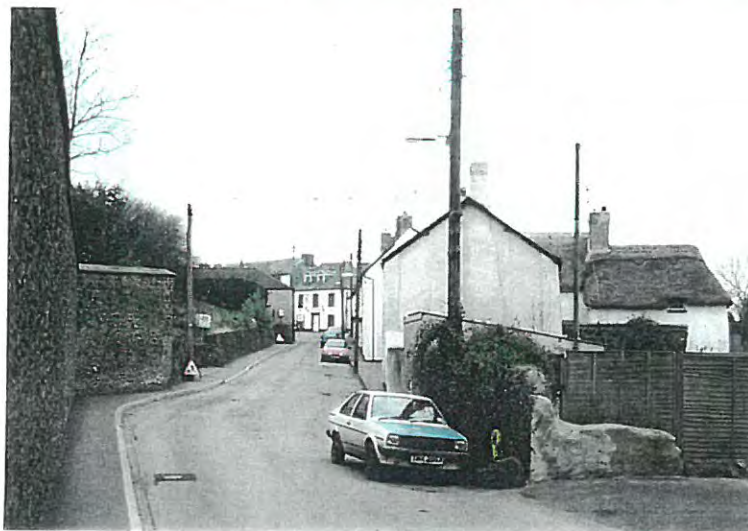
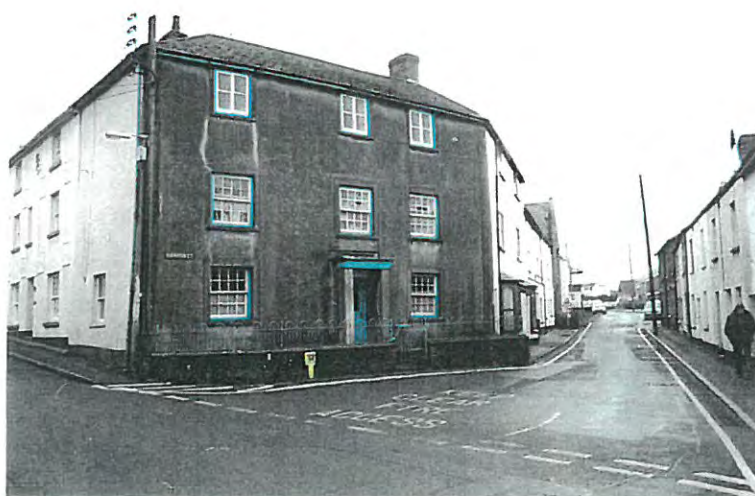
## TOWN CENTRE

*(Top left) The Square and Jubilee Clock Tower.*

*(Top right) Ring of Bells. Some pleasant detail - tile hanging, sash windows with glazing bars.*

*(Bottom right) Market Street view towards The Square. Early 20c buildings to left - mock Tudor with decorative tile hanging to eaves and good original shopfront.*

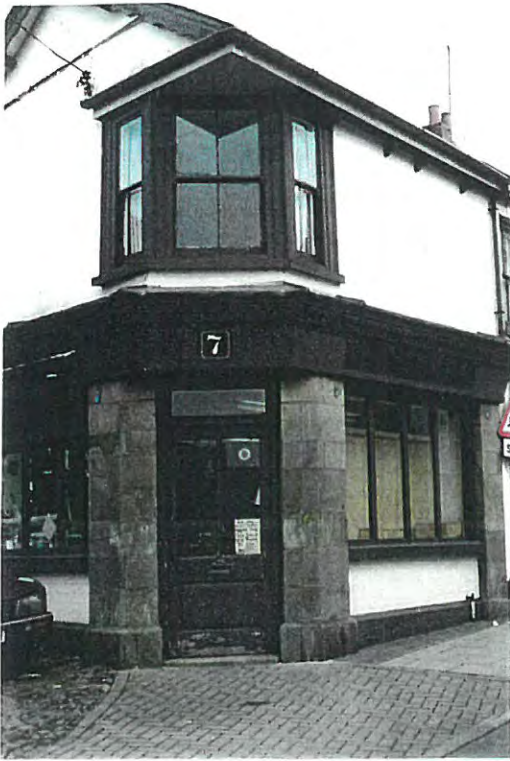
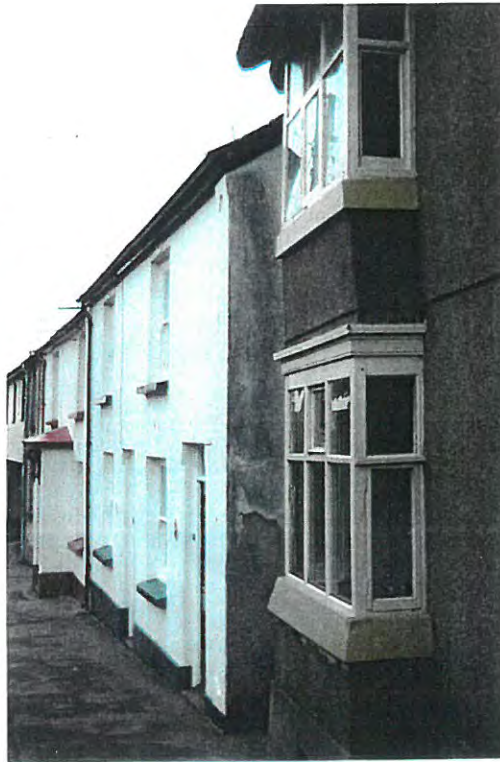
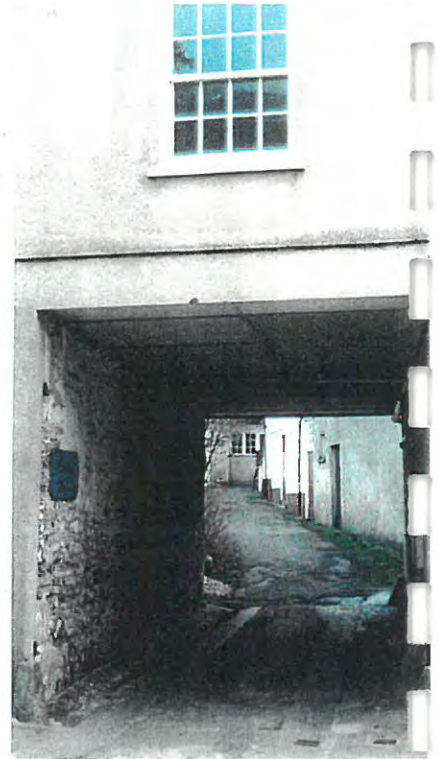
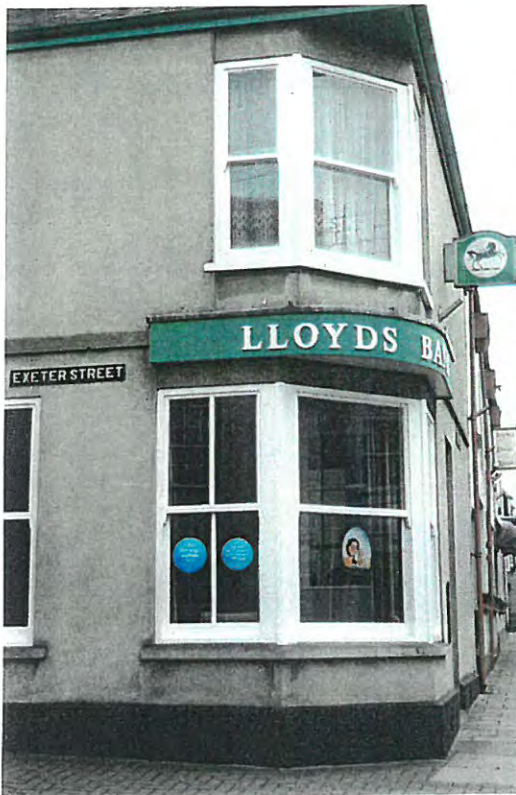
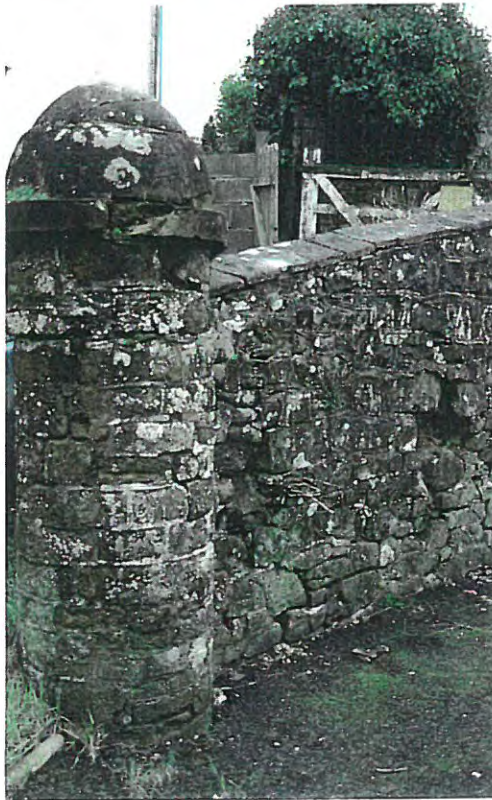
## EXETER STREET

(Top & bottom left) Where the street bend sharply is this delightful corner includi probably 19th century shopfront. Note cobbles to left and utilitarian concrete block paving which could be relieved by a least some natural stone surfacing.

(Top right) One of several carriage archways with some natural stone surfacing.

(Centre right) Section of wall and gate pier at the former Primary School in need of repair. Finding suitable replacement stone may prove difficult.

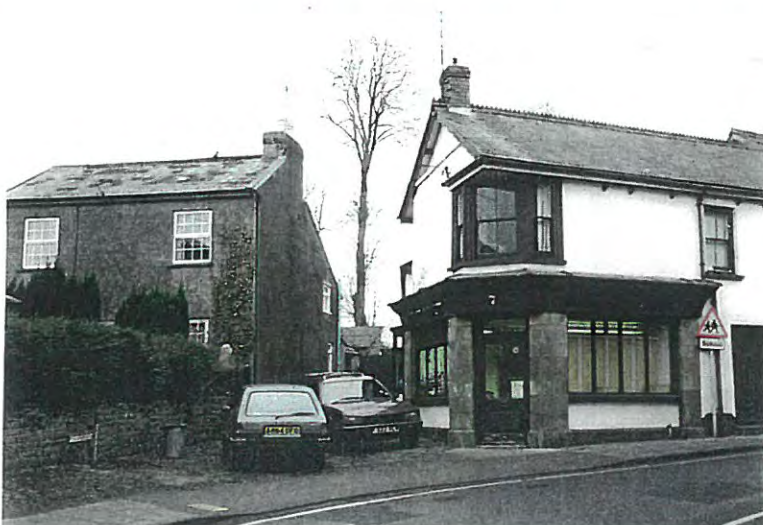
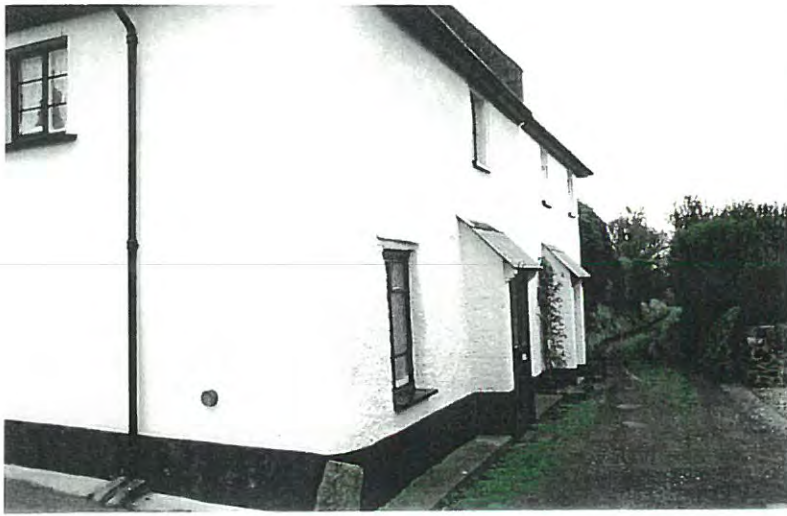
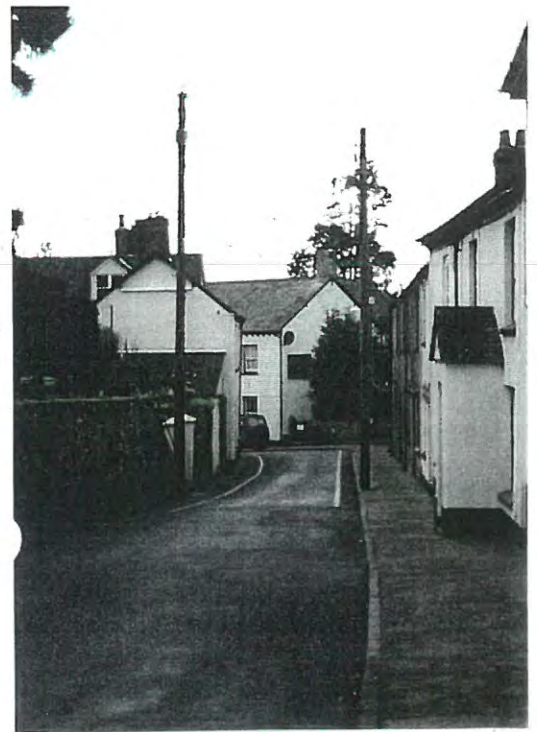
## FEATURES

(Top left) A pair of cottages off Barton Street, not currently in the conservation area. They reflect the local vernacular style but were probably once thatched.

(Centre and bottom right) Broad Park Terrace, carriage archway off The Square and footpath access off North Street all demonstrate the intricacy of the townscape in different locations. Thatch, slate-hanging, tile-capped walling are further typical features. There are remains of traditional ground surfaces: all the examples shown are in need of suitable restoration.

(Bottom left) North Street showing Nos 7-19; the first having a 1711 datestone. Note the tiny porch roof and outward sloping wall by the entrance door; an almost sure sign of a cob wall.

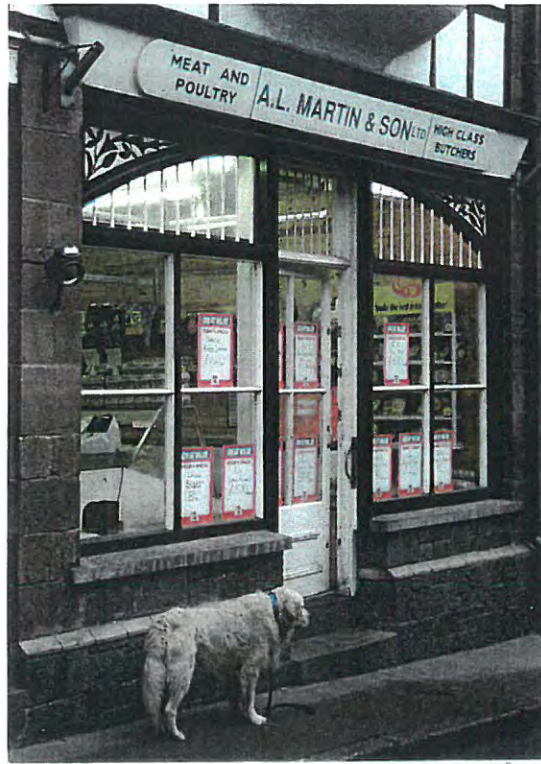
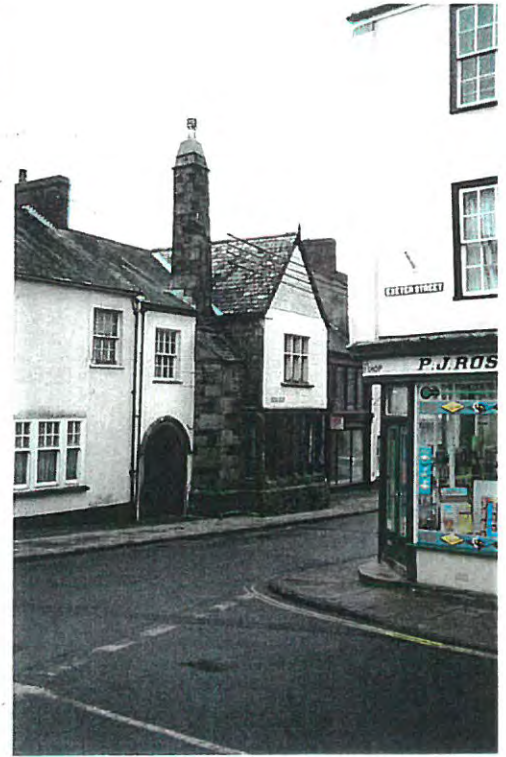
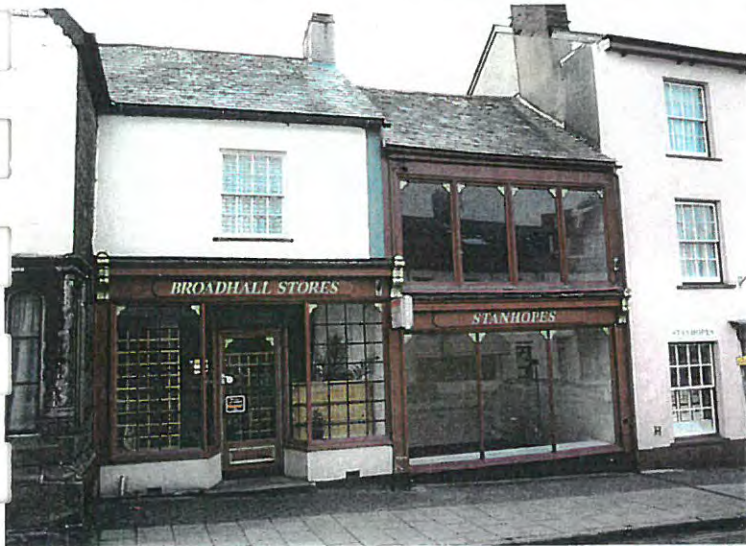
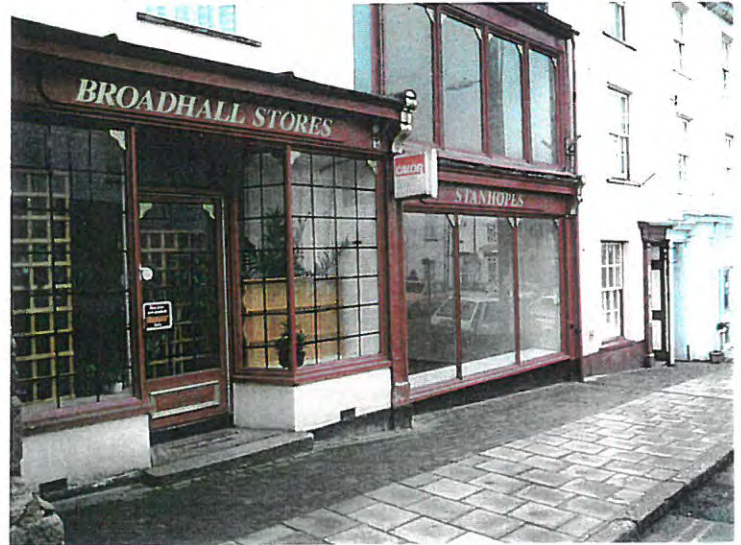
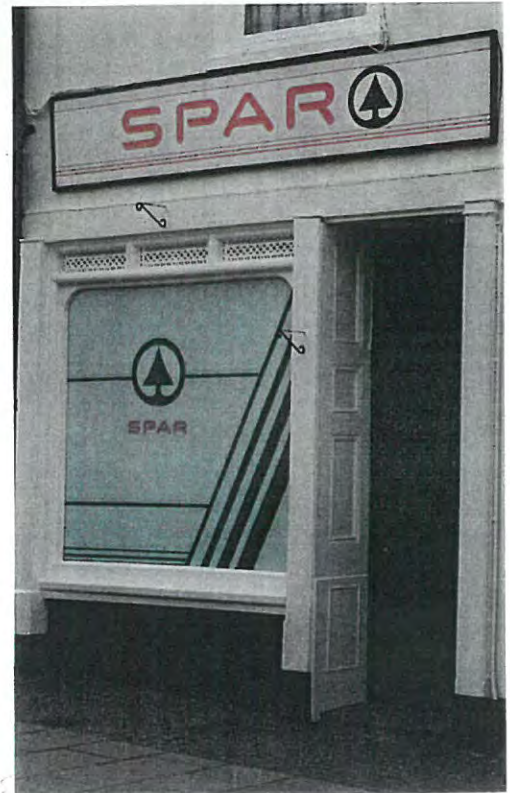
*(Top right) North corner of Exeter Street looking towards The Square. One of the best views in the town. Fine corner treatment.*

*(Centre) Two views north of Broadhall with several nice shopfronts; one former two-storey. Excellent refurbishment awaiting suitable use.*

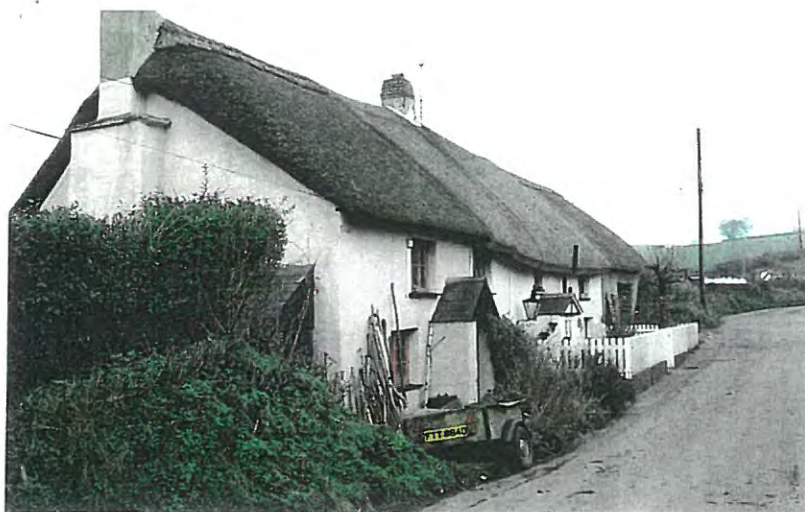
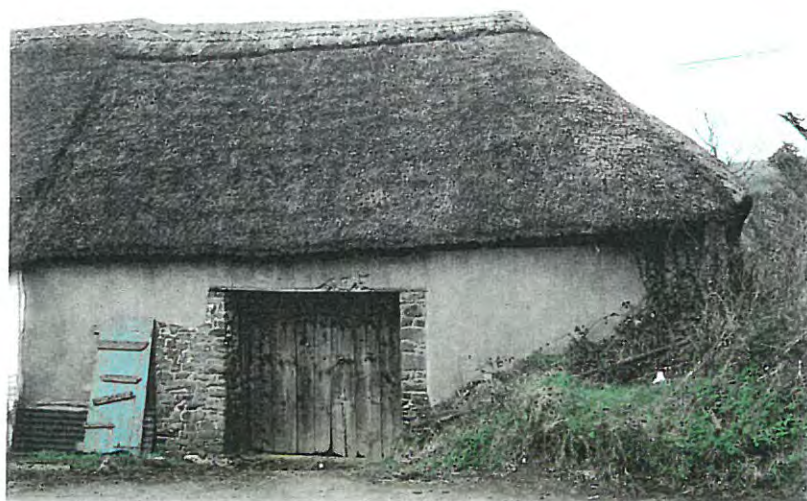
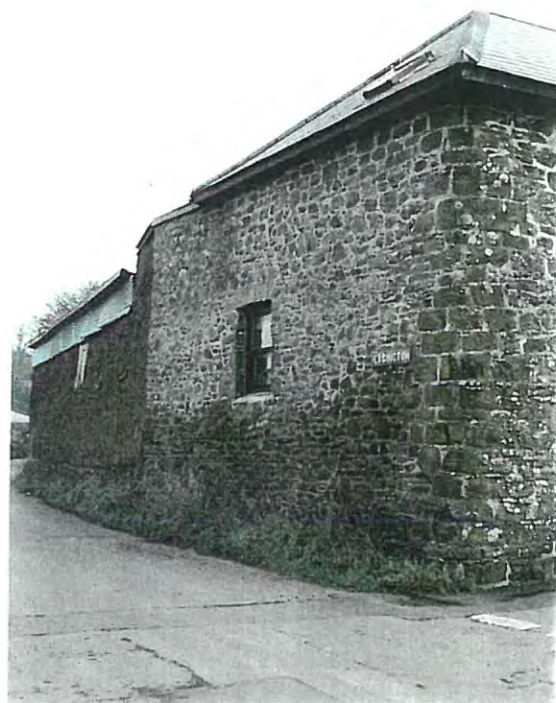
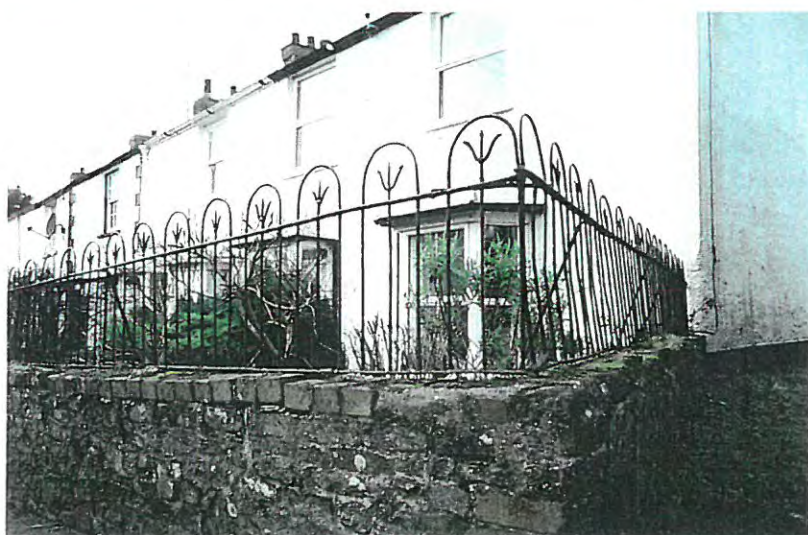
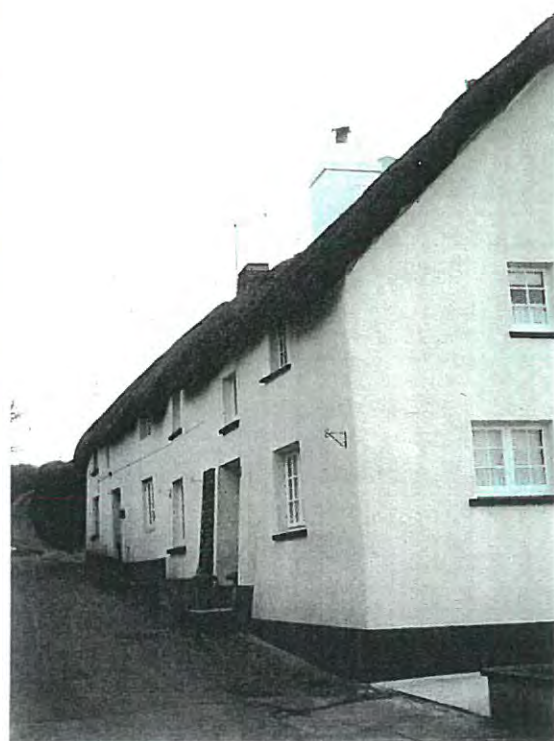
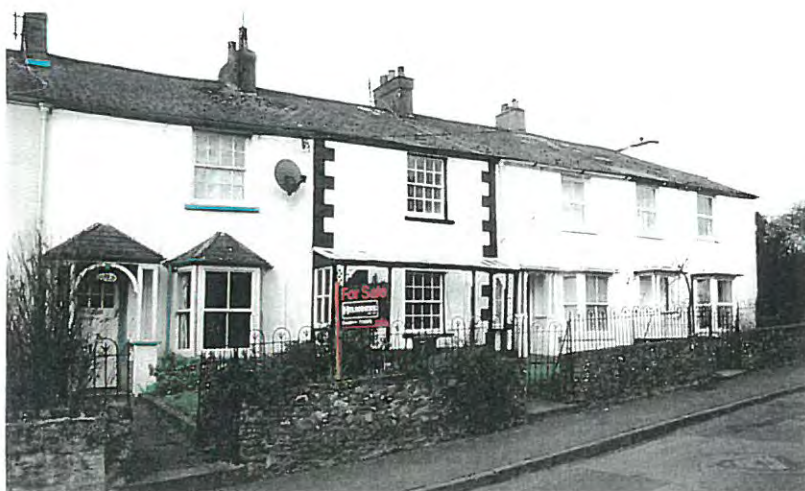
## ESSINGTON

*(Top and upper left) Nos 27, 29 Essington are part of an early 16c former farmhouse with adjoining barn.*

*(Lower right) Larkworthy cottages. Thatch and uneven cob walls show typical vernacular.*

*(Lower & bottom left) Nos 15-25 Essington; pleasant mid 19c cottages with good surviving boundary features.*

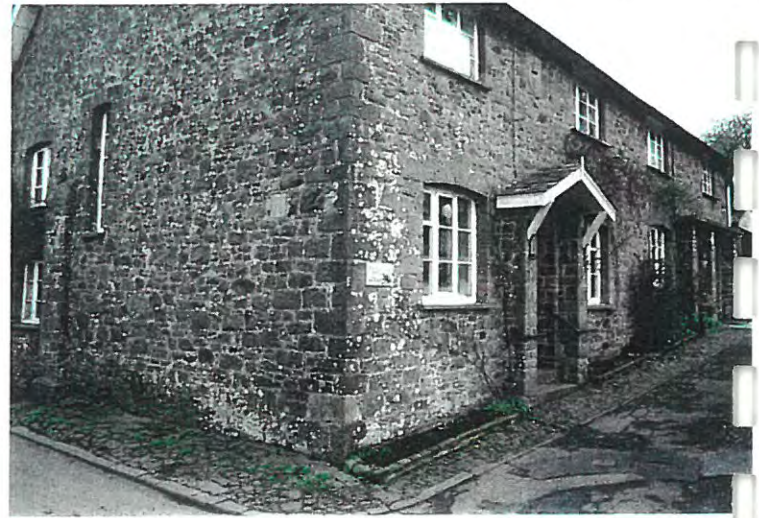
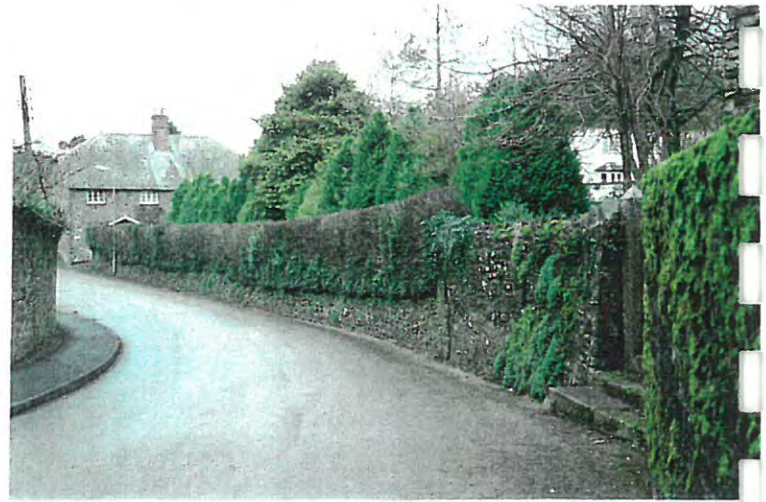
## ESSINGTON ROAD

*(Top left & right) 19th century cottages built by Lord Portsmouth (the "P" motif can be seen under the eaves above the porch). Changes in level, cobbled paving and steps add interest. Location of prominent satellite dish could be controlled by Article 4 Direction.*

*(Upper right & lower left) views in opposite directions showing the much more open character of this part of the conservation area. The parish church and churchyard lines are prominent. The young cypresses could quickly become over-dominant and raises the question of whether some tree species detract from the character of the conservation area.*

*(Lower right & bottom right) A substantial mid 19th century house, possibly with earlier origins. Sash windows, porch with trellis work, pyramid capped stone gate piers, iron railings, smooth render (stucco) are all important period features. Below, this house is shown in its setting. The entry to Devonshire House is on the left.*
