# SAFETY INSPECTION REPORT

**Site name:** North Tawton Memorial Park

**Site owner/operator:** North Tawton Town Council

**Date of inspection:** 7 August 2026

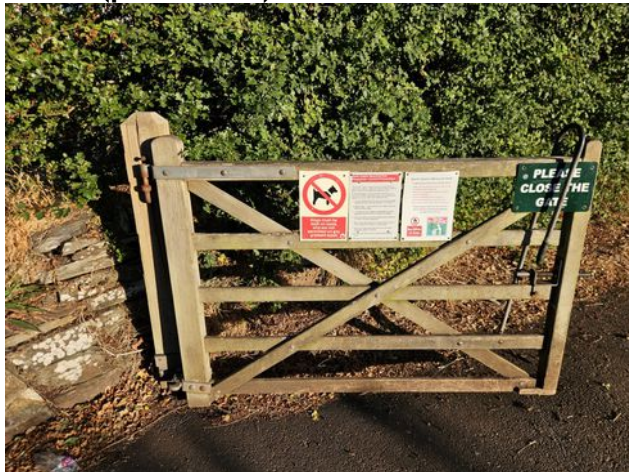
### Gates (perimeter)

Perimeter gates are of varying designs, none of which are specifically intended for children's play areas. In particular the heavy iron gates have potential for misuse. Other gates have some wear in hinges, dragging on surface, etc.

Risk: 8 (medium)

**Suggested remedial action:** Keep the large maintenance/vehicle gate locked to prevent misuse. Replace worn/damaged rubber buffers on the pedestrian side. Monitor use and consider modifications if deemed necessary. If gates require replacement in future, consider providing safer gates that are designed for play spaces.

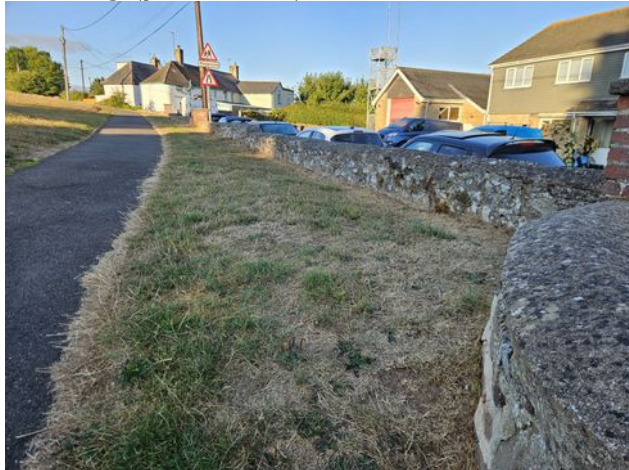
### Fencing (perimeter)

**Findings: 1.** From certain angles it could appear as though the site is fully enclosed, and the various gates give that impression as well, however there are several ways children (and/or dogs, if off lead) could easily exit the site. This includes the exit to the car park (which does not have a gate), as well as the low level stone wall which, in places, leads to a considerable potential fall onto pavement below. There is also damage to residential fencing that borders the site.

**Risk: 8 (medium)**

**Suggested remedial action:** Ensure residential fencing is repaired and there are no gaps/holes which lead from play area in to private properties. Monitor use and consider further modifications if deemed necessary.

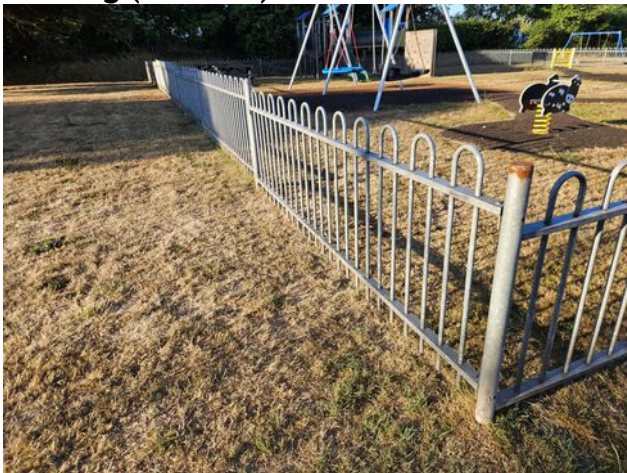
### Fencing (internal)

1. This older style of bowtop fencing with the faller top hoops contains potential for head/neck entrapment. While fencing isn't playground equipment and isn't required to meet the same standards, it is still recommended.

**Risk:** 6 (low)

2. Missing caps/plugs expose sharp-edges holes which could trap fingers.

**Suggested remedial action:** Replace missing caps/plugs.

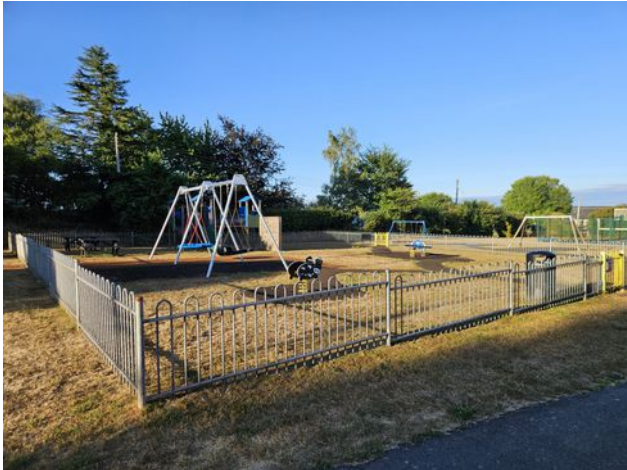
## Site General

There is an unused/redundant patch of old wetpour rubber surfacing, which has various trip hazards, etc. The surface is actually in reasonable condition and could be repaired/reused with new equipment in future.

**Risk: 8 (medium)**

**Suggested remedial action: Monitor use**

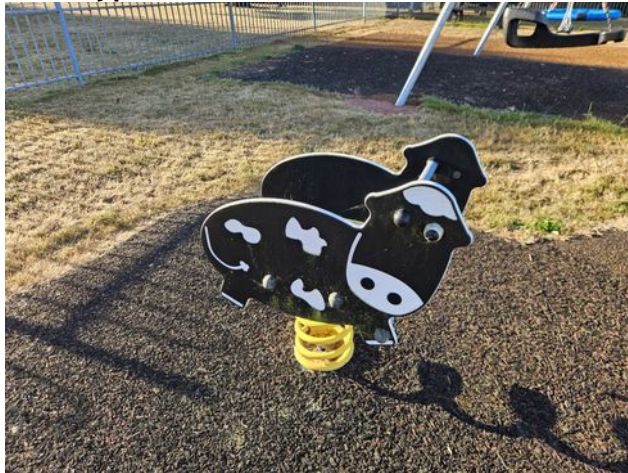
**Item type/name:** Rocker - Cow

There is significant rust/corrosion around where the rocker body attaches to the spring.

**Suggested remedial action:** Monitor for further deterioration and repair or replace as needed.

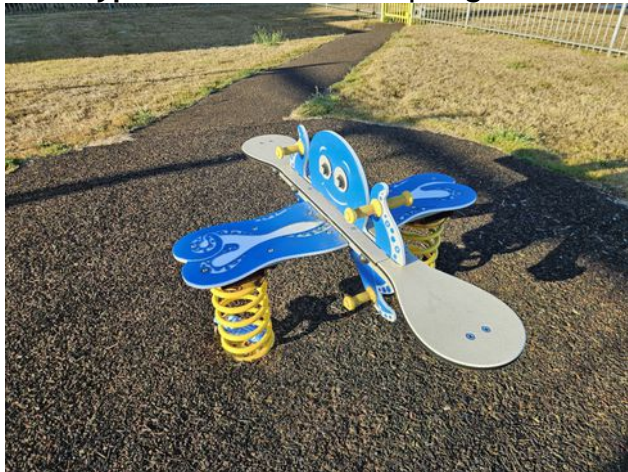
**Item type/name:** Rocker - Spring Seesaw

There is significant rust/corrosion around where the rocker body attaches to the spring (less severe than the rocker cow).

**Suggested remedial action:** Monitor for further deterioration and repair or replace as needed.

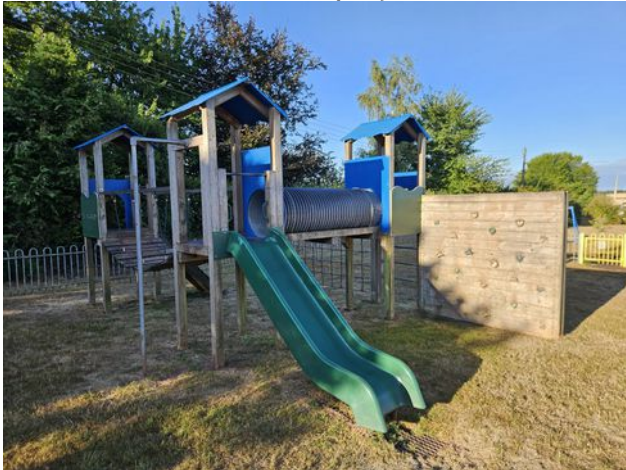
**Item type/name:** Multiplay - Junior

**Findings:** The unit is showing its age, and there is evidence of timber rot, rusty /notched fixings throughout. That being said, none of this seems to be causing any urgent issues, and the unit feels generally pretty solid.

**Suggested remedial action:** No immediate action is required, but timber rot is unpredictable, and the unit should be checked for further deterioration and structural stability on a routine basis. Replacing all of the affected timbers would likely not be practicable, so the recommended course of action is to monitor and repair where possible/practicable, and plan for future replacement of the whole unit. Pay particular attention to the climbing net and climbing wall, as these sections rely on a single post for their stability, and could fail suddenly if outer post lets go.

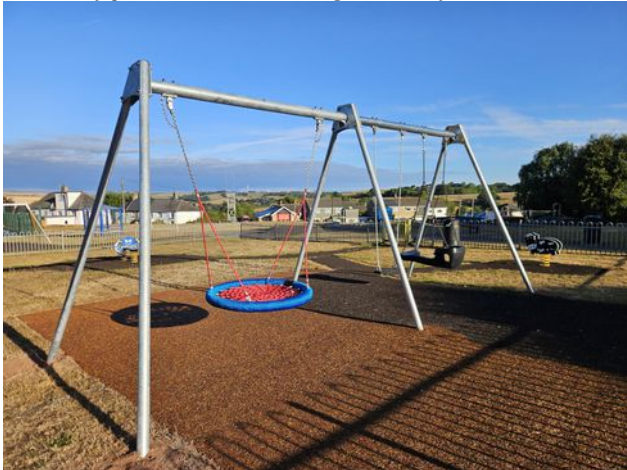
**Item type/name:** Swing - 1 bay 3 seat

The new frame, seats, and surfacing have all been installed correctly and to a good standard.

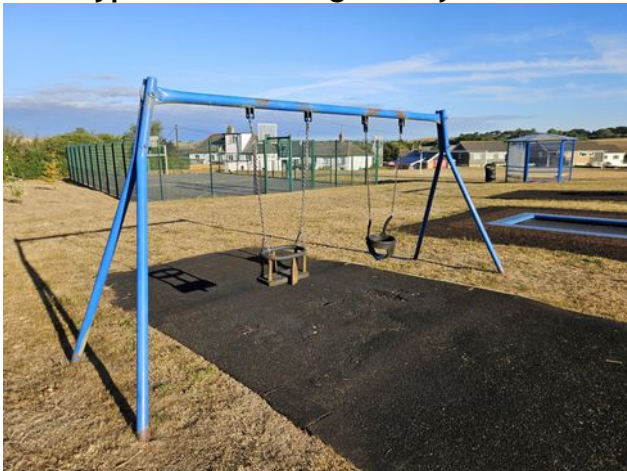
**Item type/name:** Swing - 1 bay 2 cradle

Swing frame in generally poor condition and nearing end of useful service life (without considerable repairs).

1. There is considerable rot/corrosion in swing frame at/below ground level. It is not possible to assess the full extent without excavating around the base of the legs, but frame is currently stable. Treat and paint to prolong service life.

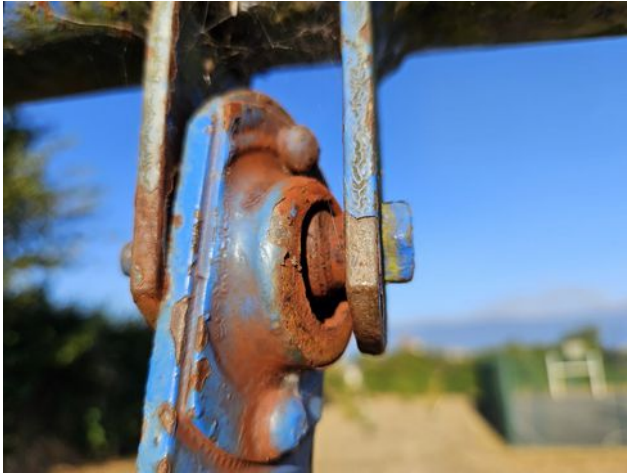
*(swing - 1 bay 2 cradle - continued)*

2. Swing hanger bushes long gone, and there is internal wear/damage to swing hangers, though, again, not causing any urgent or high risk issues.

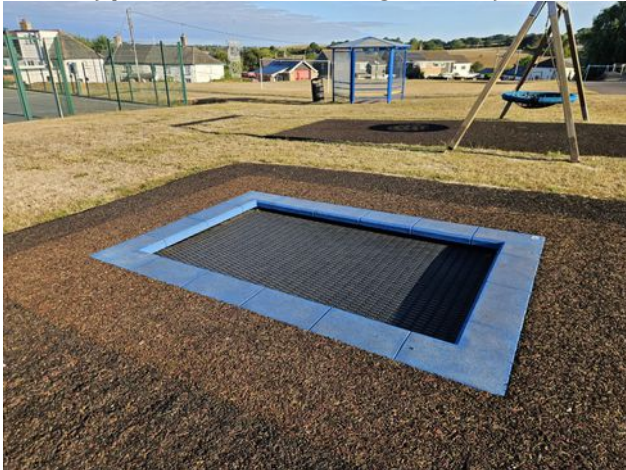
**Item type/name:** Bouncing Facility

ID tag loose/damaged, exposing sharp edge

**Suggested remedial action:** Remove damaged ID tag.

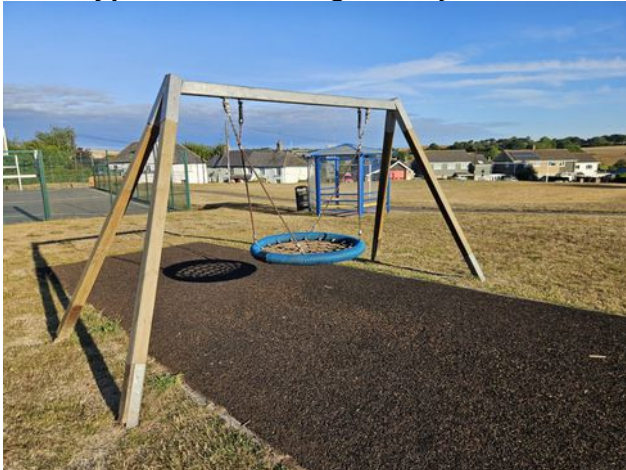
**Item type/name:** Swing - 1 bay 1 basket

1. Some corrosion / chain wear in the secondary safety chains.

2. The opening created by the secondary safety chains fails the requirements for protection against entrapment.

4. There is wear in the swing hanger bushes.

**Suggested remedial action:** Replace rusty parts.

**Suggested remedial action:** Eliminate entrapment potential by shortening secondary safety chains slightly. This can be done at the same time as replacing the rusty connecting links.

**Suggested remedial action:** replace worn bushes.

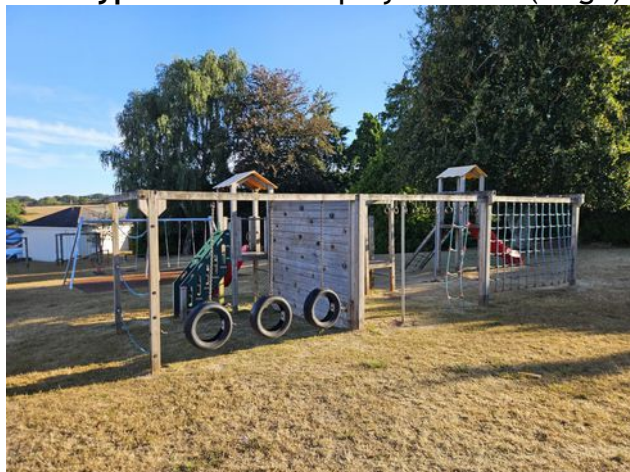
**Item type/name:** Multiplay - Junior (large)

The unit is showing its age, and there is evidence of timber rot, rusty /notched fixings throughout. That being said, none of this seems to be causing any urgent issues, and the unit feels generally pretty solid.

**Suggested remedial action:** No immediate action is required, but timber rot is unpredictable, and the unit should be checked for further deterioration and structural stability on a routine basis. Replacing all of the affected timbers would likely not be practicable, so the recommended course of action is to monitor and repair where possible/practicable, and plan for future replacement of the whole unit.

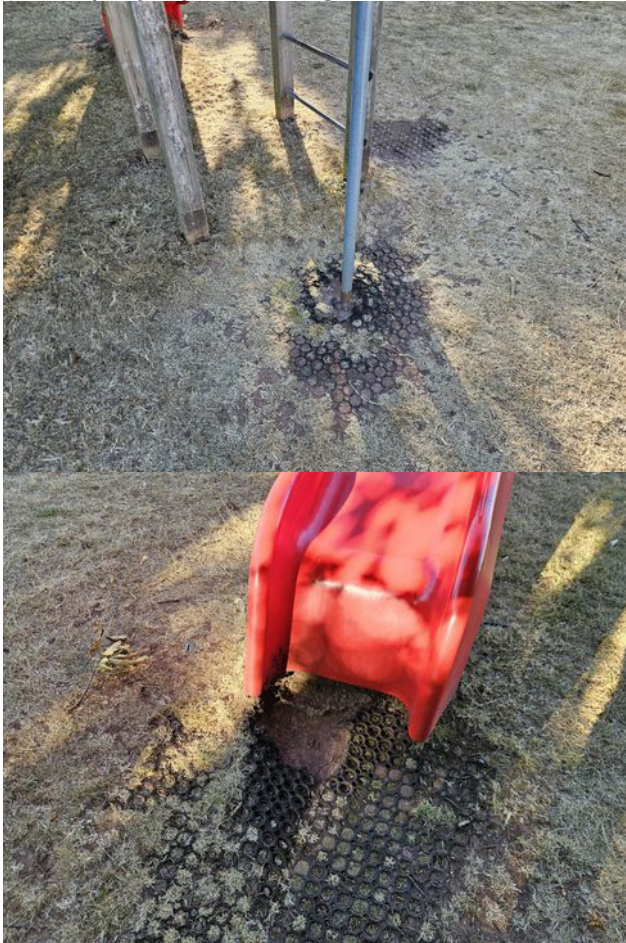
(multiplay - junior large - continued)

2. Surfacing needs repair.

**Suggested remedial action:** Repair or replace damaged sections.

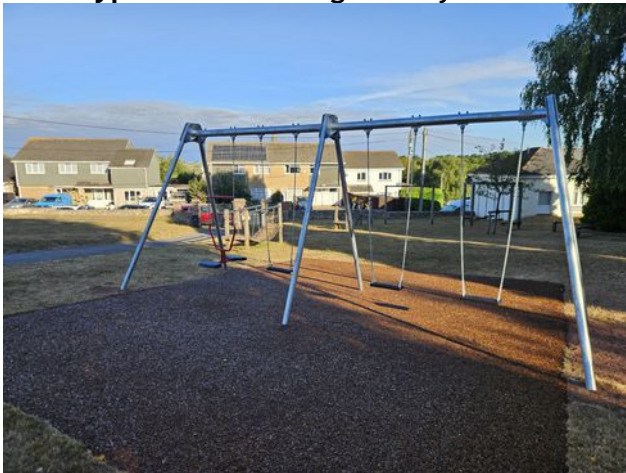
**Item type/name:** Swing - 2 bay 4 seat

The new frame, seats, and surfacing have all been installed correctly and to a good standard.

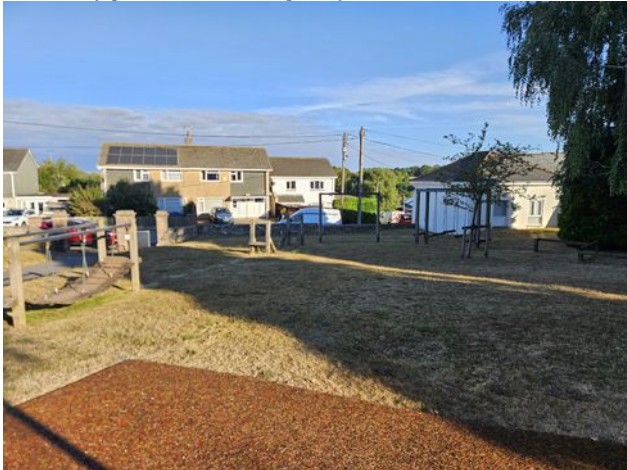
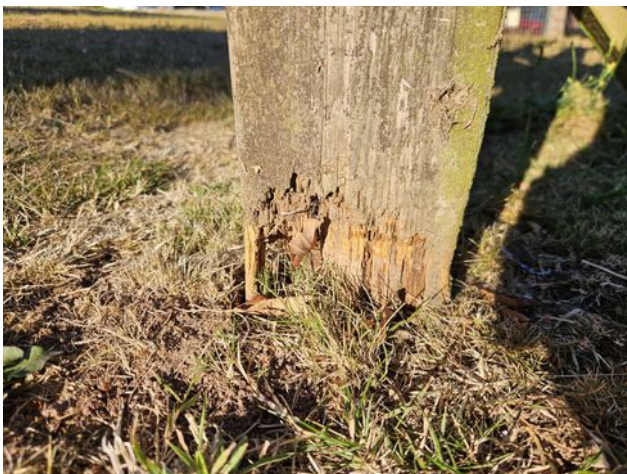
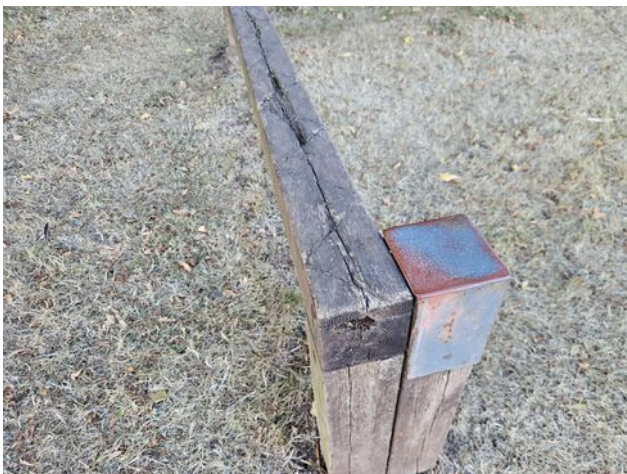
**Item type/name:** Agility Trail

The agility trail is showing its age, and there is evidence of timber rot throughout. That being said, none of this seems to be causing any urgent issues, and the various elements feel generally pretty solid.

**Suggested remedial action:** No immediate action is required, but timber rot is unpredictable, and the unit should be checked for further deterioration and structural stability on a routine basis, paying particular attention to the parts that rely on a single post for stability, with heavy overhead beams that could come down.

Monitor for further deterioration and repair or replace as needed.

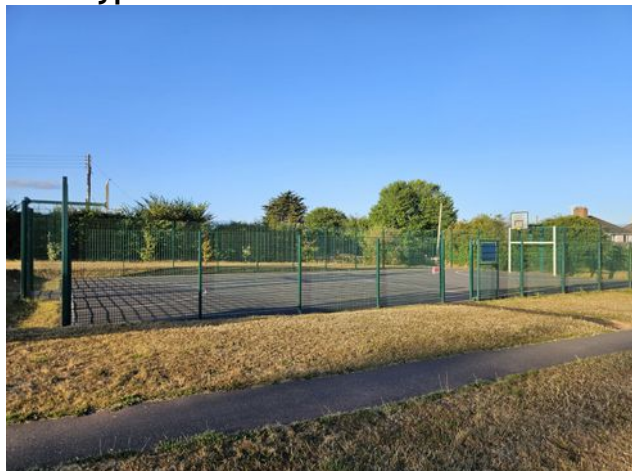
**Item type/name:** MUGA

2. Numerous slightly loose fixings around fencing. Not currently causing any issues.

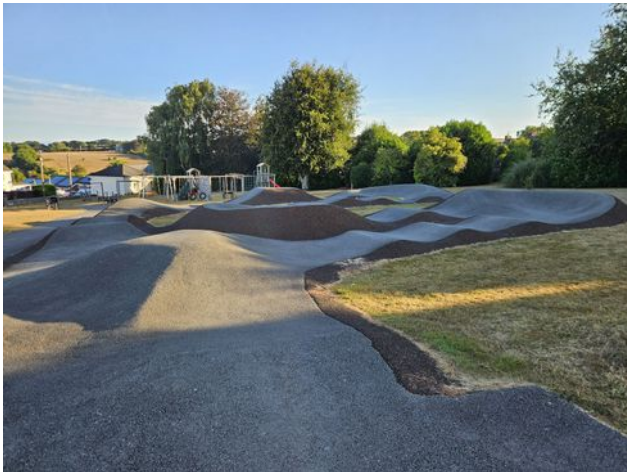
**Item type/name:** Wheeled Sport - Pump Track

**Findings:**  
Minor separation between tarmac and bonded rubber mulch edging. Not currently causing any issues.

**Risk:** 6 (low)  
**Suggested remedial action:** Monitor for further deterioration and repair as needed.

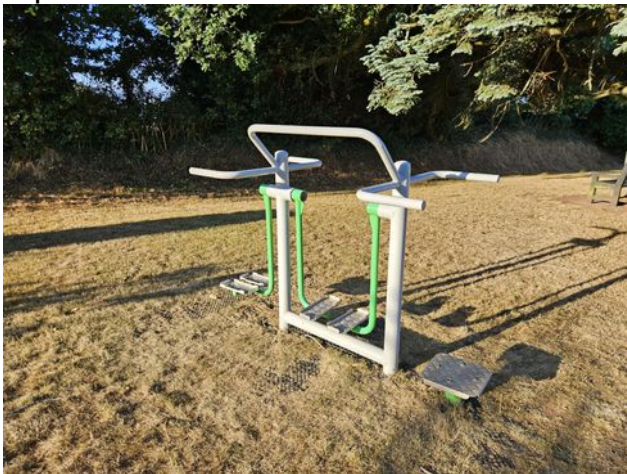
**Item type/name:** Adult Fitness - Legs / Hips

**Findings:**  
Hip twister bearing worn, and limiter function not working.

**Risk:** 8 (medium)  
**Suggested remedial action:** Replace worn bearing.
