# Safety Inspection Report

Annual Inspection

North Tawton Town Council

06 March 2026

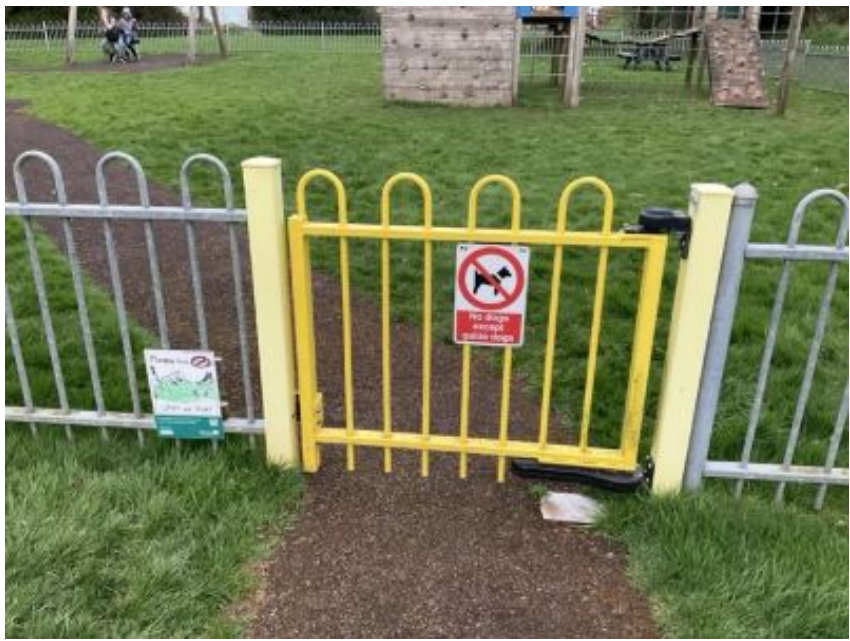
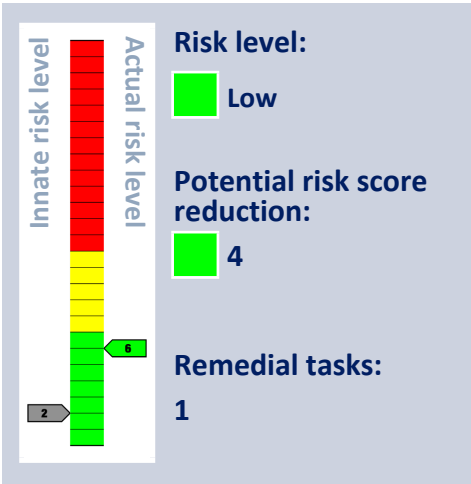
# Signage - Info

Dog ban & ownership signs recommended.

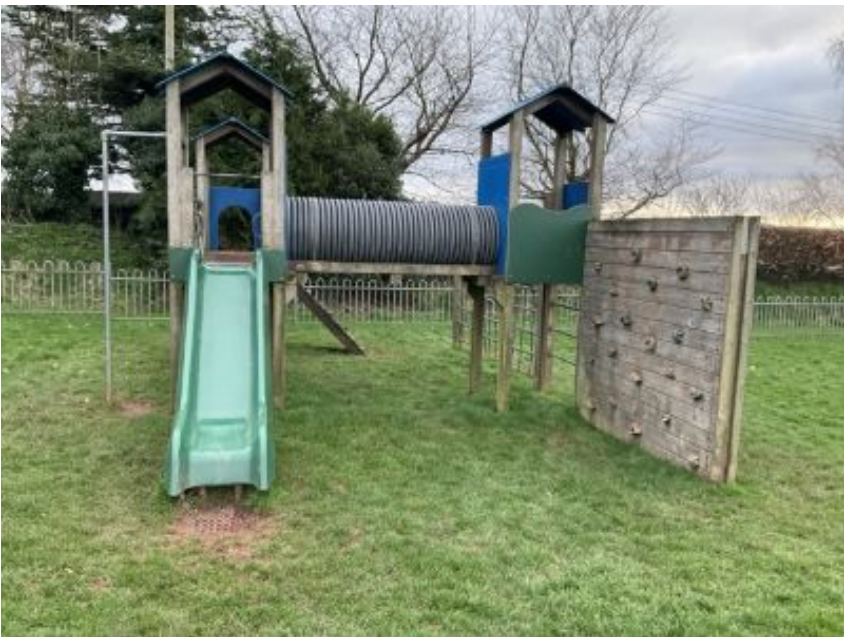
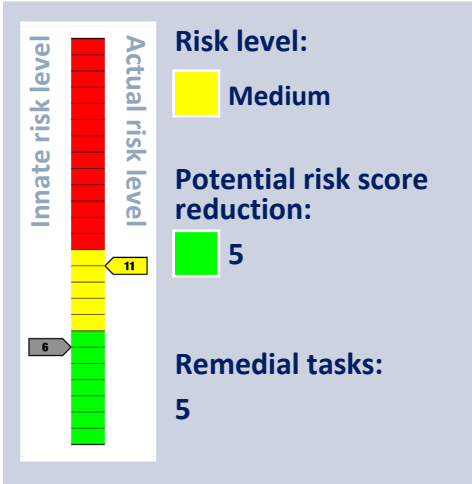
# Multiplay - Large (Fenced Area)

Timber is decayed.

Several posts decaying at ground level (see photos).

Ramp slat decayed and splintering.

Replace affected parts.

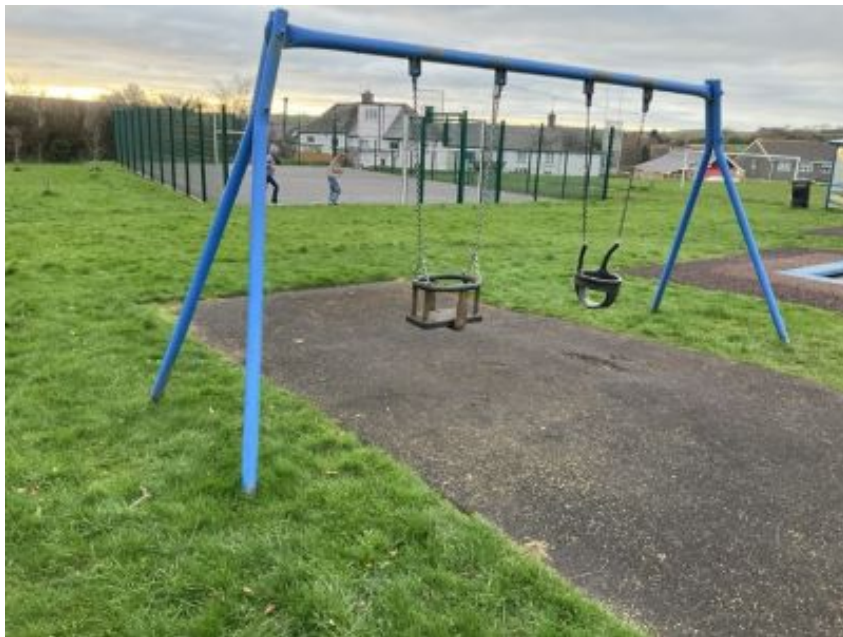
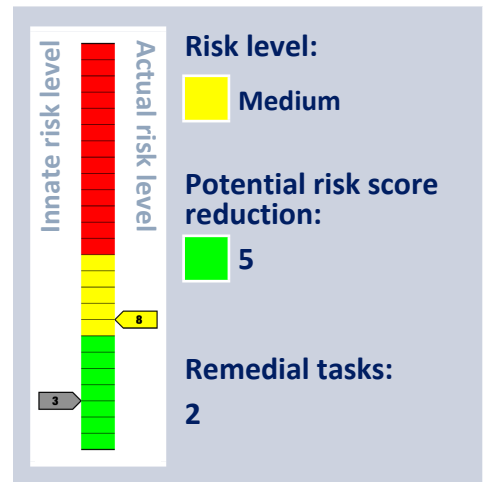
## Swing - Toddler - 1 Metal Bay 2 Seat

Surface is wearing.

Surface wearing under seat and sinking in places. Repair.

Item is worn.

Swing housing bolts wearing. Replace hangers x 2.

## Repair.

Replace.

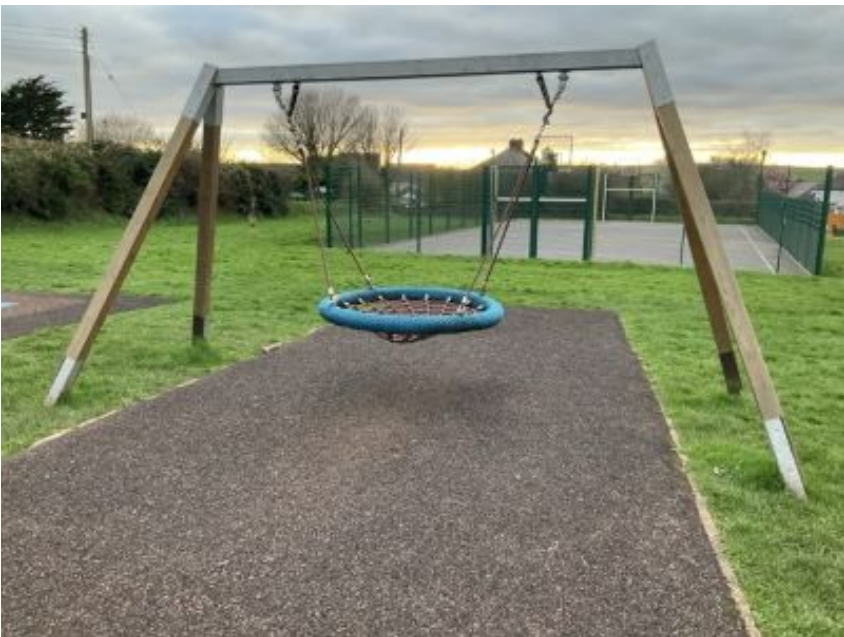
# Swing - Basket

Screws or bolts are missing.

Top bar screws to support leg have pushed through the fixing hole. Replace.

Untwist the chains to prolong their life and check for wear.
